### Battery Management isn't Black and White

George Pedersen Principal Associate Carrann Associates LLC Hagerstown MD, 21740

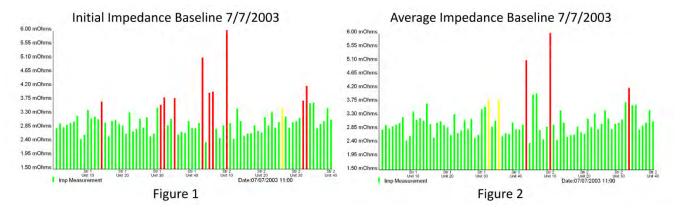
The 30% limit used was based on a graph from a document published by C&D<sup>1</sup> in 1999 that depicts the manner in which a cell and battery impedance, conductance and capacity may vary with age. Figure 1 shows the impedance values of both strings on the 7<sup>th</sup> of July.

This information was forwarded to the UPS service company, and they checked the battery using their handheld battery tester. Based on that data, they decided that only three units actually required to be replaced. The question then is, why the difference, the answer is very simple and is demonstrated in Figure 2. Using the same data as shown in Figure 1, but simply changing one analysis parameter.

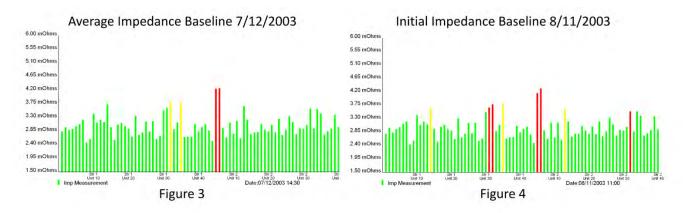
Figure 4 shows the impedance values on the 11<sup>th</sup> of August, with the alarm limits based on the initial impedances, and after the three units identified by the service company had been replaced. Five units are shown to be above the threshold, and three just below. But on the previous week's reading on the 4<sup>th</sup> of August, all eight units were shown in critical condition. This can be probably attributed to the fact that there was a 6° C change in the ambient temperature between the 4<sup>th</sup> and the 11<sup>th</sup>, and temperature affects Ohmic values.

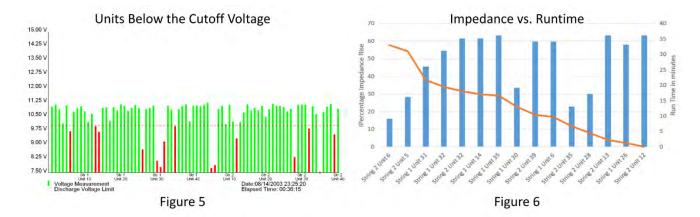
On the 14<sup>th</sup> of August, an event now known as the North East Blackout occurred, and the battery was discharged until it reached the UPS low voltage disconnect. The battery supported the average load of 55.6Kw for a period of 35 minutes which was far shorter than the 90+ minutes it should have achieved, at that load. So let's look at Figure 5, which shows the final unit voltages just before the UPS disconnected. Fifteen of the eighty units had fallen below 1.65 Volts per cell, seven more than the eight units previously identified. Figure 6 shows the correlation between the impedance values for each of the fifteen units, and their actual run time

While the graph in Figure 6 demonstrates that there is reasonable correlation between the capacity of the individual units and their impedance rise, where that rise is at least above the 30% limit level. There are four units that have run times shorter than would have been expected, based on their rise in impedance, String 1 Units 26 and 30 and String 2 Units 28 and 35. Let's look at each of the units with respect to their discharge and impedance records, to see what can be discovered.

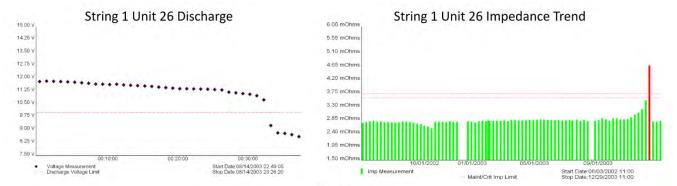
In Figure 7, Unit 26 followed the average discharge curve until almost the end of the discharge, at which time the voltage dropped off rapidly. As this is a six cell unit, the level of the voltage drop would indicate that one of the cells had failed possibly due to the failure of the pressure valve, and the resultant dry out, as that was a typical problem in that timescale. The problem is the rise in impedance of that one cell, if it had dried out, was not sufficient to raise the impedance value into the alarm region. That is confirmed by the impedance trend that showed very little change over the previous fourteen months, but it should be noted that following the discharge, the impedance did start to rise after a number of weeks and entered alarm territory just before the battery was replaced.

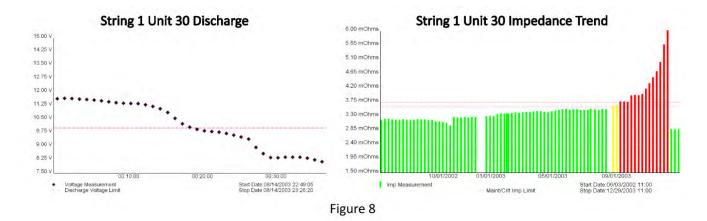
In Figure 8, Unit 30 also followed the average discharge curve for approximately 12 minutes before starting to drop into alarm territory. The rate of decline then slowed for a short period before dropping again. This is also typical of a battery which has lost capacity. In this case, based on the step pattern of the discharge more than one cell was failing and the impedance trend graph shows that the impedance had been rising steadily and that rate of rise increased rapidly after the discharge.

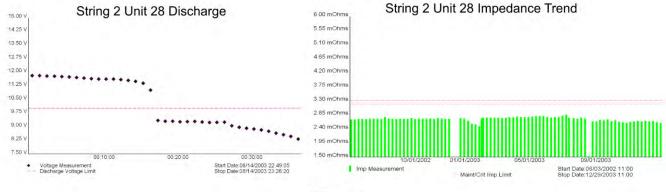
In Figure 9 with Unit 28, the voltage again drops rapidly part of the way through the discharge, again indicating the loss of a cell, but then stabilizes for a period before continuing a slow decline. The impedance trend graph is very stable, and remains so after the discharge. So while the unit clearly has a problem with one of the cells, the reason for the loss does not appear to accelerate the failure process in the other cells as in the previous two examples.

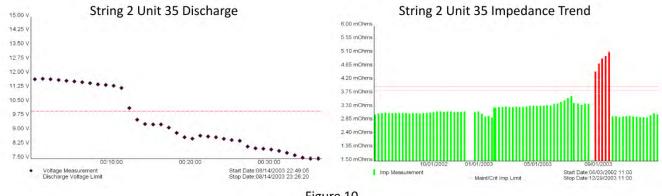
In Figure 10, the unit voltage continued the pattern of the previous two units, dropping into the alarm zone part of the way through the discharge. But this time it fell much further than in any of the other units, indicating multiple cell failures. The impedance had also been rising in the months previous, but had dropped again five weeks before the discharge, but then rose rapidly following the discharge requiring the unit to be replaced just five weeks after the discharge. This would tend to indicate there was some additional problems with that unit, and the failure mode was not just loss of capacity.

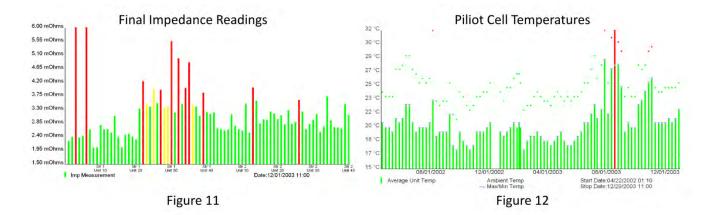
This clearly was a battery with problems, and six of the battery units that had failed during the discharge were replaced in September. By the end of the year as shown in Figure 11, there were 11 units that were above the 30% threshold, and a further five approaching the 30% mark, so the battery was replaced in the beginning of December.

When a battery deteriorates at the rate this one did after a discharge, it is always worth looking further to see if there is an underlying factor that could have impacted battery life. The most obvious ones are the number of discharges, and the operating temperature. In this case other than the example shown here, there were no real discharges, but Figure 12 does show that the temperature was subject to fluctuations from as low as 17° C and up to 32° C. This could definitely have had an impact by increasing the corrosion rate and possible dry out.

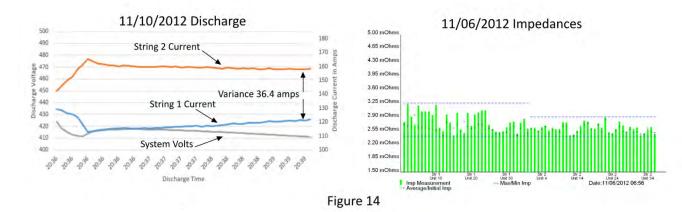
At the discharge on the 10th of November 2012, the variance between the two strings as shown in Figure 14 had increased to 36.4 amps, and the impedances had clearly started to rise, but as the graph shows they were still below the preset alarm limits of 30%.

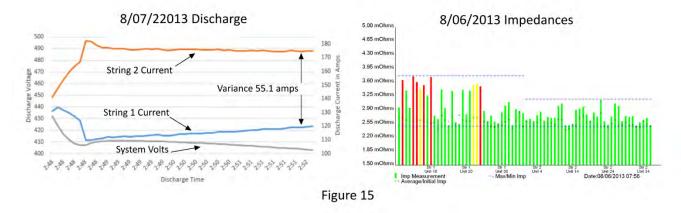
For reasons unknown, the automatic discharge test was turned off for a period, and the next recorded test was on the 2nd of August 2013. At this point the variance between strings was now 55.1 amps, and there were 7 units all in String 1 that were indicating above the 30% rise alarm point as shown in Figure 15

On the 25<sup>th</sup> of October 2013 the six units that were over the 30% limit were changed, and the automatic discharge test was again turned off. On the 27<sup>th</sup> of April 2014 a further nine units were changed for exceeding the 30% threshold, and the only other measurable discharge subsequent to that, is a 5 second discharge on the 11<sup>th</sup> of July 2014. The data for that discharge is shown in Figure 16.

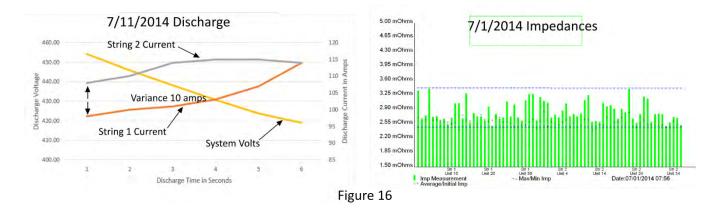
Although all the impedances are once again below the 30% threshold, and the string currents appear to balance at the five second mark. There is still a ten amp difference when the discharge is initiated, indicating that there is something inhibiting String 1. Since that time, a further six units have been changed out: four in String 1 and two in String 2 for a total of nineteen in String 1, and two from String 2.

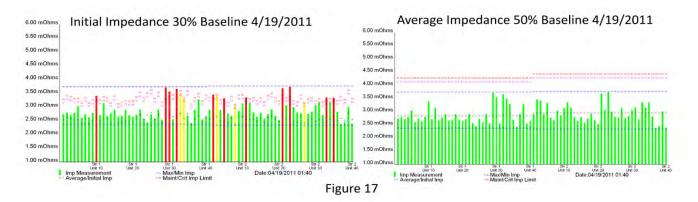
#### The impedance plots for April 2011 are shown in Figure 17

Our next example is a perfect example of this. Here we have another two string UPS battery installed in October of 2008, and monitored on a continuous basis. The first unit to exceed the 30% critical limit was in April 2010 in String 2, and during the following year a further ten units exceeded the 30% limit. Four in String 1 and six in String 2. The UPS company service group were advised in April 2011 that a number of batteries required replacement. So they did their own assessment, and reported that they found no units that exceeded their specifications, (a 50% increase in impedance over the average baseline).

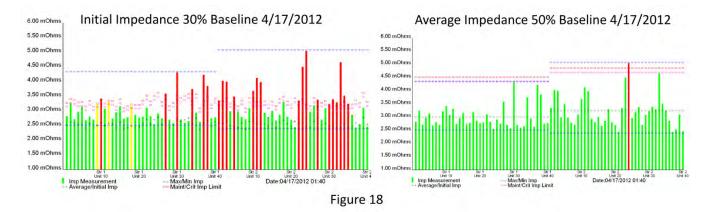
The number of units over the 30% threshold continued to increase, and on the 17<sup>th</sup> of April 2012 there were six units in String 1, and seventeen units in String 2 as shown in Figure 18. The UPS company service group were again notified, and when they checked they found one unit that exceeded their specification, but advised the customer that it didn't present a risk to the system, so it could be replaced at a later date.

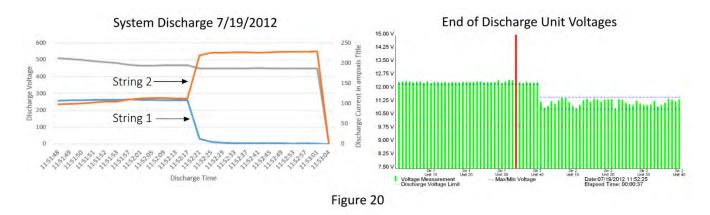
At the customer's request, a discharge test was carried out on the 19<sup>th</sup> of July, and as can be seen in Figure 20 the results were catastrophic. At approximately 30 seconds into the discharge the current in String 1 dropped to zero, and String 2 assumed all the load. After a further 39 seconds the load dropped completely.

So what happened? As noted earlier String 2 had the most units over the 30% limit, so it would have been reasonable to believe that any early failure would occur in that string. But as I indicated at the start of this example, "Murphy Rules" and indeed he did. It was unit 34 in String 1 that went open circuit, which was a unit that had never been identified as a potential failure. By the manner in which the Voltage and Current in String 2 also dropped rapidly, it is reasonable to assume that a unit in that string also went open circuit. But as this would also have removed power from the battery monitor before the next scan occurred, the actual unit in String 2 that failed cannot be identified.
