How to Avoid a Starring Role in a Really Ugly Case Study. Stupid errors easily avoided.

**Dan McMenamin
President
Dan McMenamin and Associates, Inc.
West Deptford, New Jersey**

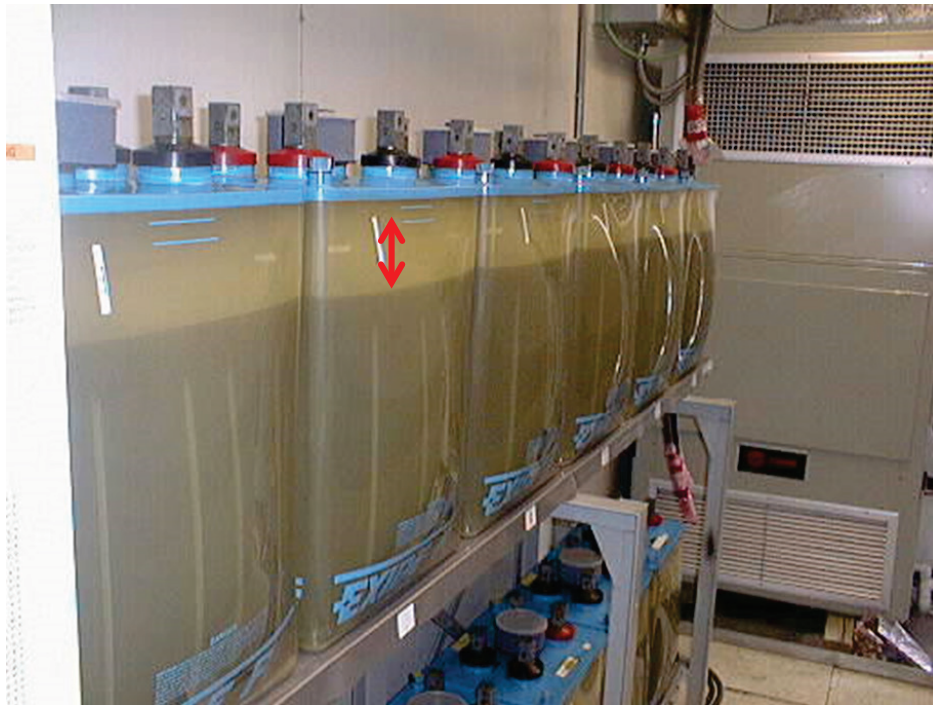
Figure 1 is a photograph showing irreparable damage to a flooded string of 1,680 ampere hour cells that was caused by a mishandled HVAC system failure in a telecommunications installation. Over a span of approximately 60 hours, the room temperature climbed to approximately 130 Degrees (F) (54.4⁰ C).

Note the bulging evident on the sides of the battery jars. The jar material was PVC which softens at approximately 160 degrees (F) (71⁰C). Accordingly, the battery itself became an electric heater to some degree, as a result of energy from the dc power plant rectifiers dissipated across the battery's decreasing internal resistance. Under such overcharge conditions, electrolyte water is electrolyzed, producing copious amounts of hydrogen.

Note also, that as the jar sides bulged out, the electrolyte level dropped well beneath the distal end of the fill-funnel tube of the explosion-resistant vent atop each cell. These abnormal conditions placed the cell head-space (if not the facility itself) in a very serious threat of explosion once the hydrogen concentration in a given volume of air would reach 4% or greater.

Figure 1. Lead calcium battery cells with jars that bulged due to an overheating condition in the wake of an HVAC system failure. Note the drastic electrolyte level drop (Arrows) that resulted from jar bulging.

Take-away: Facility high temperature alarms should be responded to promptly. Either something bad has already happened or will in time.

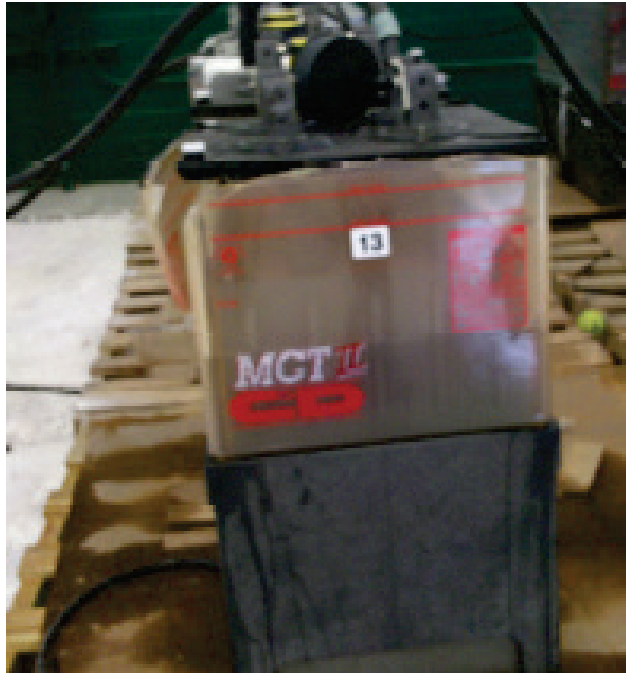
In this case, as is shown in Figure 2, the head-space of a mishandled 4,000 Ampere Hour cell exploded. At the time, a group of 24 cells held in warehouse storage was temporarily wired in series for a 150 hour, 60 volt 'Freshening charge.'

At some point, a technician removed the explosion-resistant vent cap from one cell and a resultant ESD event caused ignition of hydrogen in the cell headspace which exploded.

Figure 2. A 4,000 AH cell being boost-charged exploded as a result of an electrostatic discharge.

Take-away lesson: It's important to follow manufacturer's literature when handling any kind of battery.

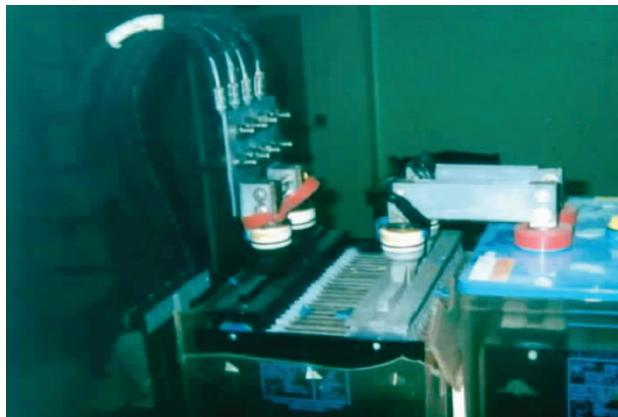
Another cell headspace explosion occurred (Figure 3) when a technician touched the top of a 3,900 Ampere Hour cell in Float charge operation. In this case, rather than place a step ladder to reach the upper tier of the string, a technician dragged a plastic chair across a tile floor and then stood upon it to service the battery. Dragging the chair generated a triboelectric charge sufficient to initiate the event.

Figure 3. A 3,900 AH cell exploded when an electrostatic discharge as a result of a technician's errors.

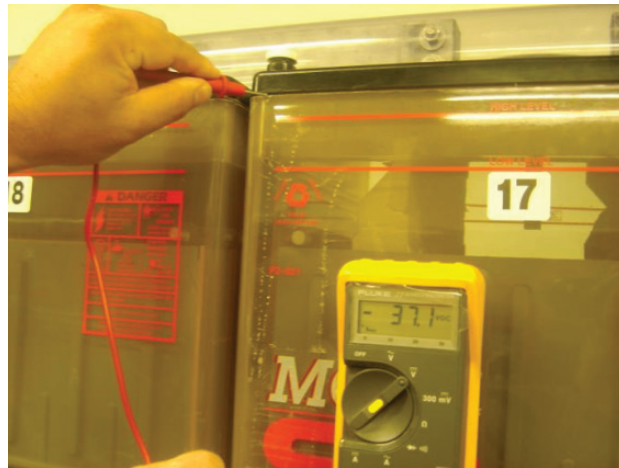
Figure 4. A leaking jar-to-cover seal could become the energy source that results in a battery fire.

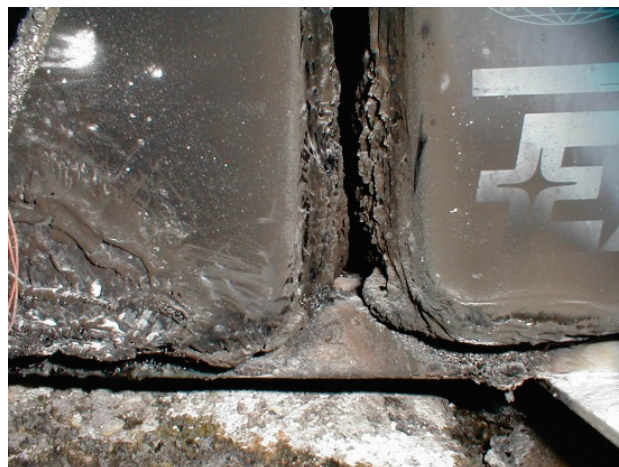
Figure 5 shows two of twenty-four 4,000 Ampere-hour cells that were damaged by an external fire that began with a small crack that occurred during installation. Electrolyte seeped from a small crack in the corner of a cell and initiated a fire. The fire propagated along spill containment bags beneath the cells and the heat from that fire charred the plastic containers above them.

Figure 5. A leaking jar resulted in fire to spill containment bags beneath a battery.

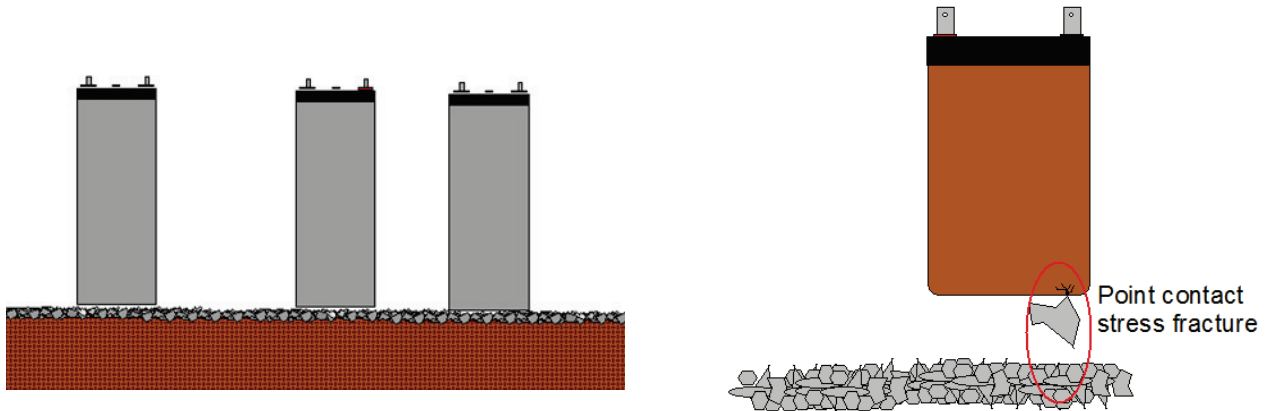
To place unprotected cells on gravel or steel walking surfaces can cause overstress point-contact damage to the containers of those cells. Such damage can result in electrolyte leakage and fire as well as early failure due to loss of internal pressure in VRLA cells. VRLA cell containers (also called jars) are pressure vessels. During normal float operation, water in the electrolyte is electrolyzed to produce oxygen at the positive plate. In a pressurized environment, this oxygen passes through to the negative and recombines back into water that becomes absorbed into the electrolyte within the cell. If this pressure vessel becomes compromised, oxygen leaks out into the atmosphere and cannot then recombine into water within the damaged cell.

Figure 6. Placing cells on gravel or other surfaces with sharp, pointed edges can result in container failure due to stress cracking.

Take-away lesson: Plywood is cheap; battery fires are not.

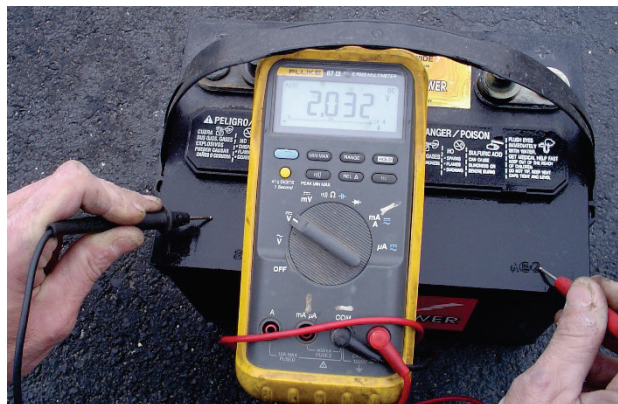
VRLA battery cells can leak from overcharge because under such conditions, the pressure vents can open and release a small mist of electrolyte that can accumulate on the tops of battery containers. Maintaining battery cleanliness is important because a variety of contaminants on the top of a battery can cause misdirected energy (short-circuits) that can compromise battery capacity, at best, or initiate combustion. Figure 7 shows a twelve (12) volt monobloc battery with a film of electrolyte that spread along the top cover, probably a result of misting from vent release during an overcharge condition. This unit is in need of neutralization and cleaning followed by Ohmic testing to see if its condition is suitable for continued service.

Figure 7. As is seen, there is a two (2) volt loss across the top of the cover as a result of electrolyte leakage.

Take-away lesson: It's important to respect the necessary precautions during installation to avoid container cracks and to discover them during maintenance and take appropriate remediation action.

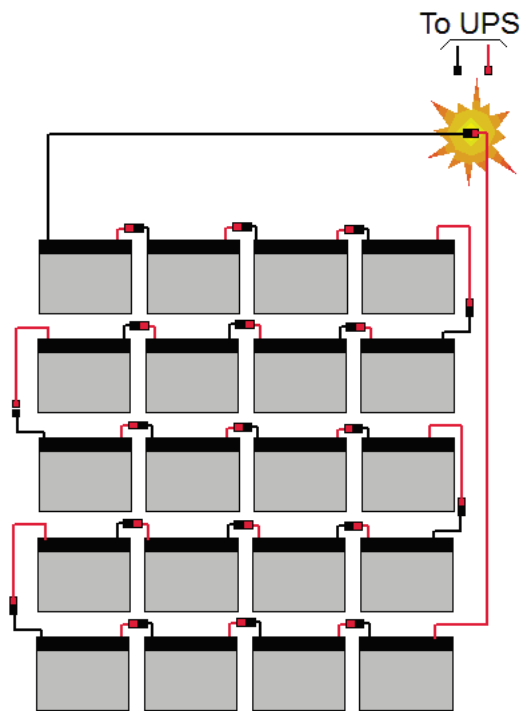
The technician apparently lost concentration while plugging red-to-black, red-to-black and instead of connecting the last two to the UPS, he plugged them together short-circuiting the entire battery (see Figure 8). When he misconnected the two connectors their contact surfaces welded together. For a time, he struggled to separate the welded connectors during which the battery units overheated and produced sufficient smoke to trigger early warning detectors that brought in fire alarms. The building was evacuated as a matter of procedure. A telephone company technician passed by while evacuating and suggested that the panicked technician disconnect a pair of connectors that had not welded. The battery technician did so but by then the battery was badly damaged and in need of immediate replacement.

Figure 8. A technician inadvertently dead-shortened a string of monobloc units by plugging together connectors that were intended to connect to a 40 KVA UPS.

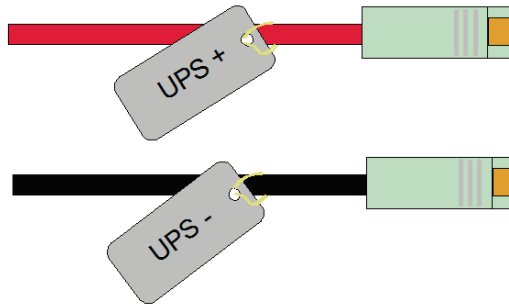
Figure 9. The use of inexpensive tags early in the installation would have prevented the accident discussed above.

Take-away lesson: Tagging leads to avoid mistakes is fundamental to reliability on electrical tasks.

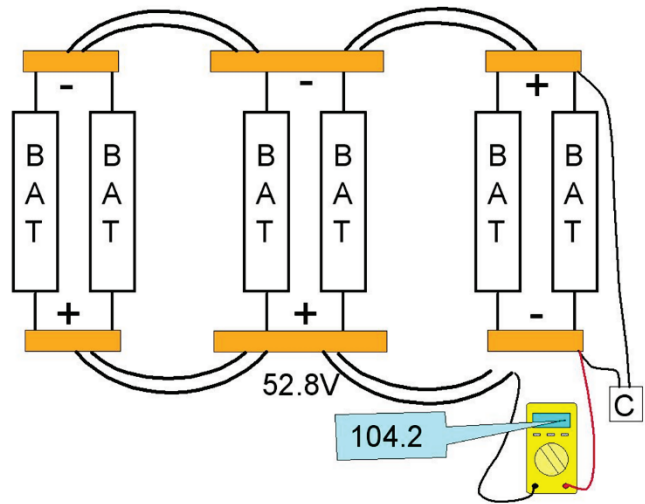
The cabling plan utilized a pair of copper splice plates as the interface between very flexible cables to the battery strings to larger cables intended to connect to the existing battery bus as is seen in Figure 10.

The first contributory error was that an installation technician mistagged the leads between the splice plates and the battery bus. As a result of the tagging error, the two additional battery strings would be connected to the battery bus in the opposite polarity with respect to the existing strings.

Figure 10. Anatomy of this accident. The two strings to the right were being added and accidentally were connected in reverse polarity.

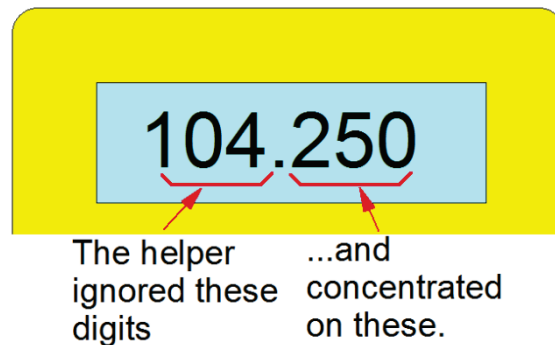
Because the two new strings were, in fact, connected in reverse polarity, the voltmeter measured 104 volts. As is shown in Figure 11, the technician’s helper either didn’t look or didn’t grasp the significance of 104-point-*something* volts on his meter. He adjusted the charger until the meter displayed what he thought was less than 0.250 volts, when in fact the difference in potential was 104.something volts.

Figure 11. How the helper misread the display on his voltmeter and caused the accident described above.

Take-away lesson: Training, supervision and attention to safety are non-negotiable requirements for any power job.

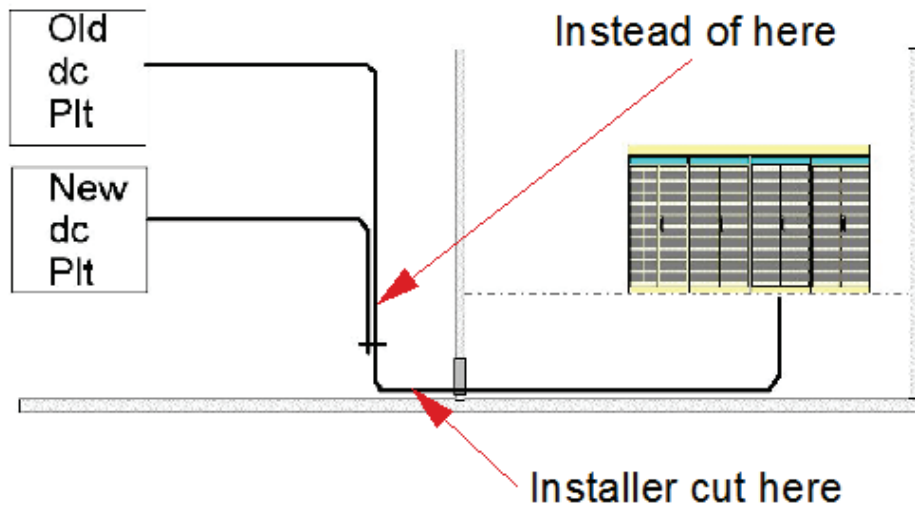
As is shown in Figure 12, the switching system was located on a raised floor in a room adjacent to a storage room. The existing dc cabling came across the storage room and then dropped on a vertical cable rack to the floor level and then entered the switchroom via a cable hole in the partition wall.

The cabling was run from the new dc plant and connected in parallel with the cabling from the legacy dc plant. During a midnight to 6 AM “Maintenance Window”, the installer erroneously cut the leads on the wrong side of the H-taps, thus accidentally depowering the switching equipment.

Figure 12. Installer error.

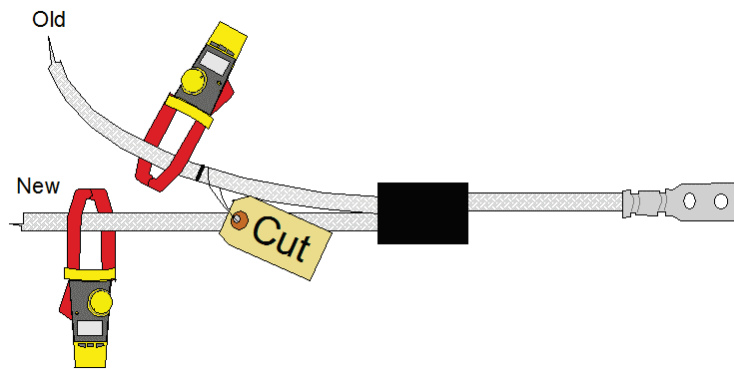
Figure 13. Simple ways of avoiding the problem

Had the lead to be cut been checked, verified and tagged (Figure 13) in the Method Of Procedure (MOP) process, it’s likely that the accident wouldn’t have occurred. Also, if a clamp-on dc ammeter was employed during the transition, the correct load “rollover” would be accomplished.

Take-away lesson: Every step of a Detailed Method Of Procedure (D-MOP) needs a verification step and any leads to be cut need to be well identified beforehand.

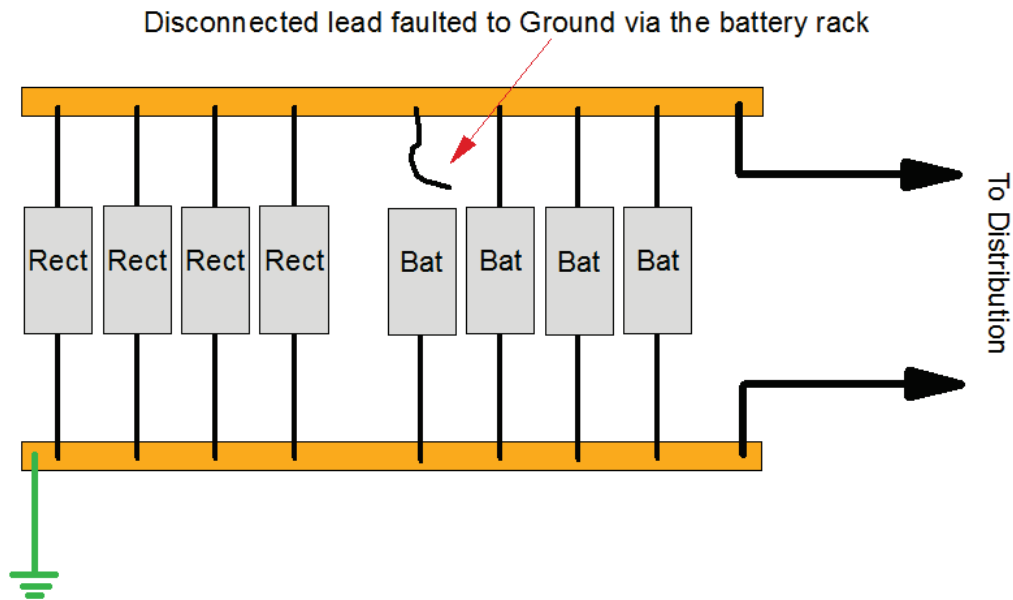
In the case being presented herein, a helper with two weeks on the job and no training was told to disconnect and remove an obsolete string of vented batteries in a central office. His Level 4 installer – a 'Lead man' in some parlance – was working elsewhere in the building³.

Unfortunately, this helper was working on the battery of a -48 volt power plant and therefore the positive poles of the battery strings are grounded. Further, the string he was removing was only one of many parallel strings in the dc plant. By taking his father's advice and disconnecting the plant cables from the negative side of a battery string and then letting those cables drop against the framework (a ground source) a major arcing event ensued and caused the failure of telecommunications systems in the central office.

Figure 14. Illustrates the accident discussed above.

Take-away lesson: All persons performing work on power equipment must be of a skill Level appropriate for the task. The specific installer names and their skill levels should be identified on the D-MOP.

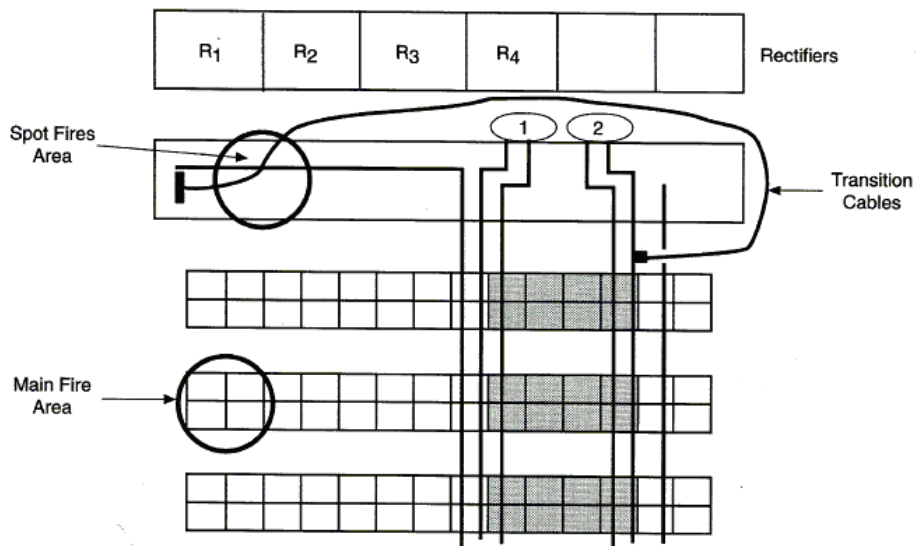
Figure 18. An excerpt from the NFPA report.

Figure 18 is an excerpt from the NFPA report from the incident and it shows the placement of “Transitional Cables”. Their purpose was to bypass the motor operated switch for the transition from twenty-seven to twenty-four cell operation. Figure 19 has a better illustration of the transitional cables (drawn in red) showing their relationship to the dc plant elements.

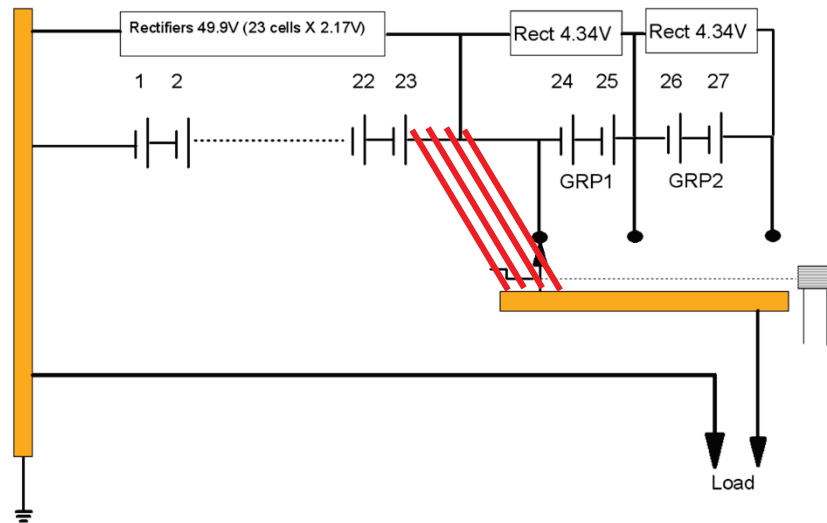
Figure 19. Shows the transitional cables (drawn in red) showing their relationship to the dc plant elements.

When things go wrong, they do so very quickly. At the time of this accident, the transitional cables were in place and the fuse for the switch motor was removed to prevent its operation. During work activities, the dc plant controller falsely operated a relay that caused all rectifiers to shut down. The particular relay was a high-voltage shutdown feature that signals all rectifiers to shut down until a manual intervention took place. At that point, all the installers needed to do was to press a reset button on the front of the power board and the High Voltage Shutdown relay would have returned to a normal state and rectifiers would have restarted. Unfortunately, the installers didn't understand the problem or the particular button^{vi} and so they tried numerous other means to restart the rectifiers all of which failed.

The transitional cables were temporary and as such they were supported by canvas straps which burned through fairly quickly. Once the support straps burned through the transitional cables fell onto grounded framework and also onto a busduct carrying three phase 480 Volt bars fused at 1,600 amperes from an ac switchboard. In addition to the electrical faults caused by energy from the shorted End cells, once the transitional cables touched a ground source, the eight strings of twenty-three cells also fed into the fault. The available fault current rose to something approaching 400,000 amperes. The sheet steel housing surrounding the busduct burned through quickly adding a high-power ac fault component to the harrowing dc fault for the clearing time of the ac circuit breaker.

Take-away lesson: (1) As in many documents, sometimes the words get in the way and a simple sketch paves the way to understanding. Transition sketches should be part of any D-MOP covering power or major Grounding transitions. (2) Don't assume that an installer knows how equipment operates just because he or she is experienced at installing it. Many system elements are a "Black Box" to installers. Require a Skill Level 4A technician or vendor field engineer for transitions or major plant or Grounding modifications.
