WHEN THERMAL RUNAWAY STRIKES, WHAT SHOULD YOU DO?

Mark Dixon
Chief Engineer
ABM Engineering Services
Sacramento, CA 95816

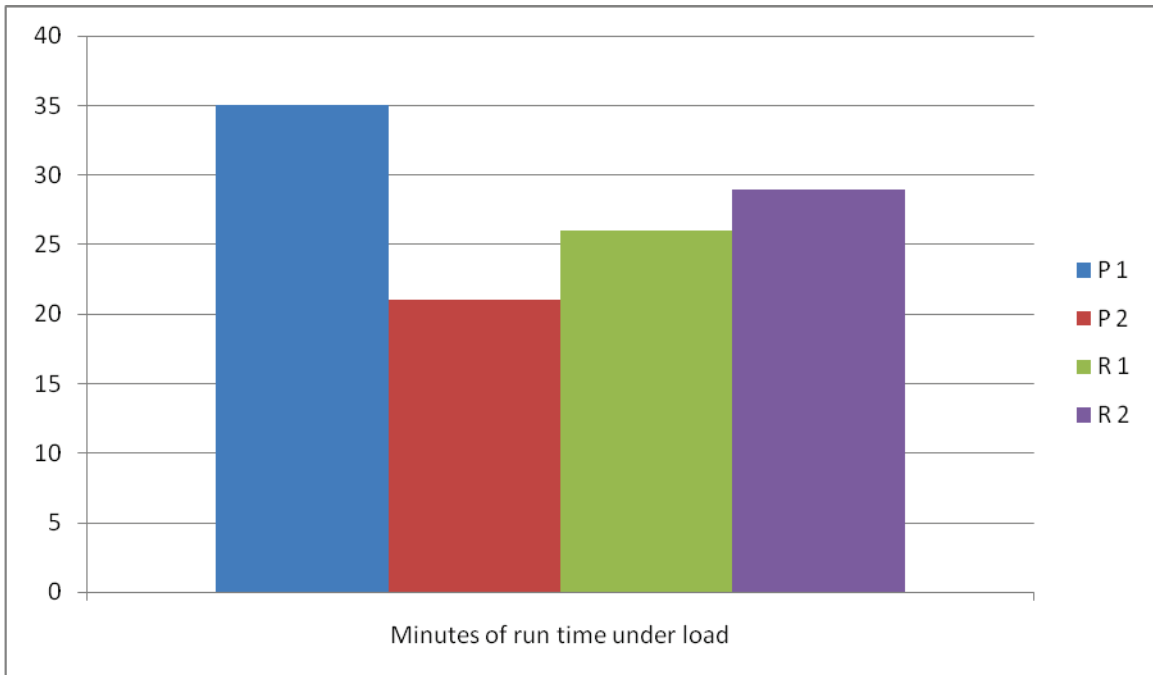
This time it was decided to run the load tests at a rate that would duplicate our actual loads, so that we could at least determine if we could indeed ride through a loss of utility power. The loads ranged from 280 to 285 KW. With this amount of load, these batteries should have been able to run for about 90 minutes. These tests that were run on June 20, 2009 and provided us with a “sort of” comfort level as the run times ranged from 21 to 35 minutes with P-2 at 21 minutes (Figure 1). These results showed us that the batteries would still allow us to safely transfer to our generators which take less than 60 seconds to start up, and take over the loads during a loss of utility power. However, the battery company’s report recommended that we replace the batteries ASAP due to a statement that the IEEE 1188 Standard states that a battery that performs at less than 80% of its rating is increasing in its rate of deterioration (Figure 2).

Two days later on June 22, 2009 battery P-2 had cell temperatures from 180 – 200 degrees F. This battery was in a full blown thermal run away. To halt this event, we transferred the loads to our reserve modules and opened the battery disconnect to stop the charging current and to isolate that battery from the system. The following charts show the run times at load and the percentages of capacity for each of the battery strings during those load tests.

Figure 1 – As found run times under duplicated site loads.

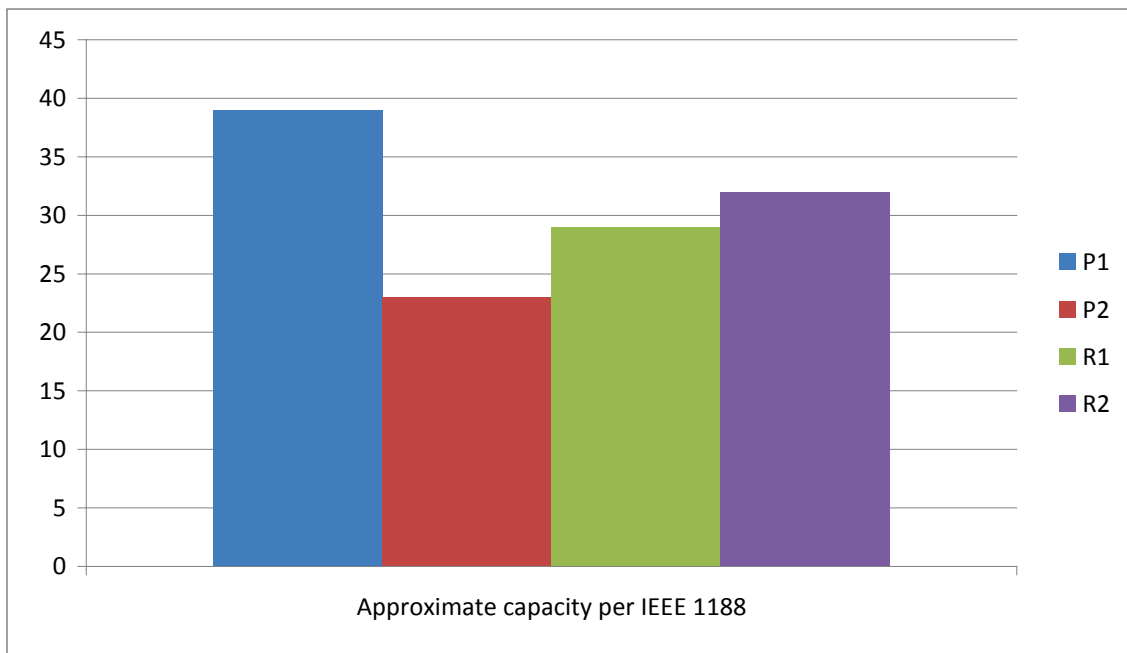
Figure 2 – Approximate capacity following IEEE 1188 Standard.

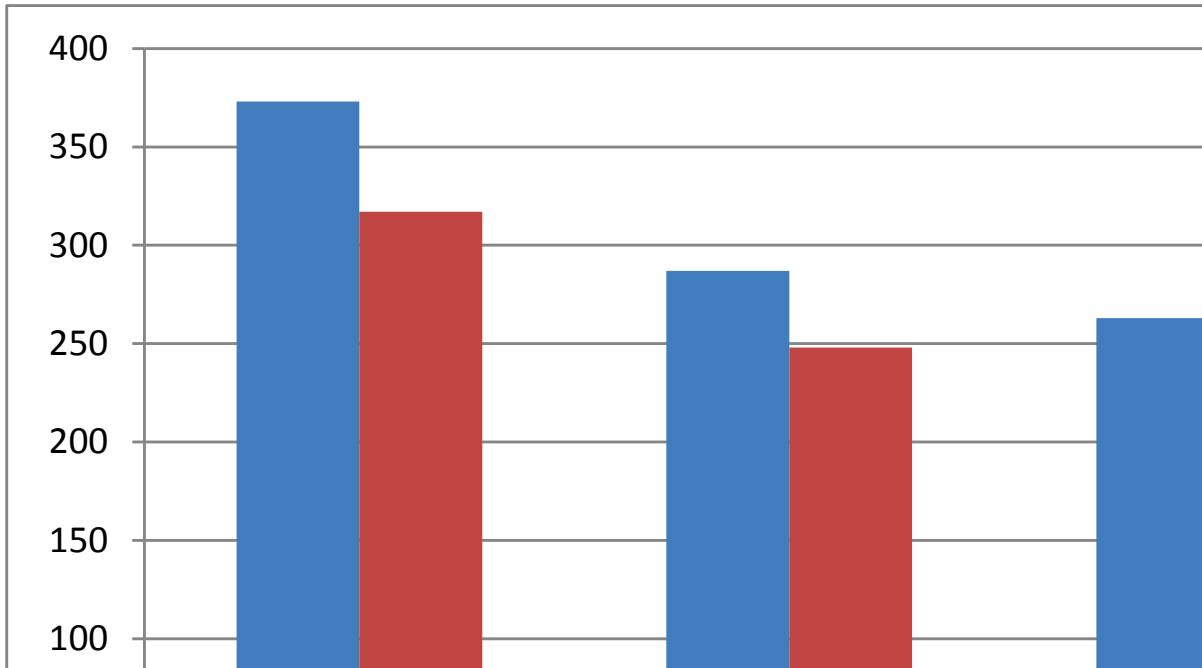
The immediate results were that the ohmic values of the cells made a drastic improvement as can be seen from the before and after values in the following “Average Cell Resistances” chart. At the same time the float currents lowered substantially as can be seen in the “Float Current” chart. We of course were happy with these results as we did not want another thermal runaway, but awaited the follow up load test results to make our decision as to the success or failure of the project.

Figure 3 – Pre and Post IOVR+™ process, average cell internal resistances.

The team that performed the service was made up of three individuals, and required the string to be off line when they were working on making specific checks and the addition of water to each cell. While their exact steps were proprietary, it can be summed up in that after they determined the structural integrity of each cell, they added varying amounts of water based upon the ohmic values that they measured prior to the structural integrity check. Then this was followed by a high rate charge, more measurements, some more water to individual cells “fine tuning” as they called it, more boost charging, then the installation of a catalyst in the head space. This work was performed during the first two weeks in August 2009.

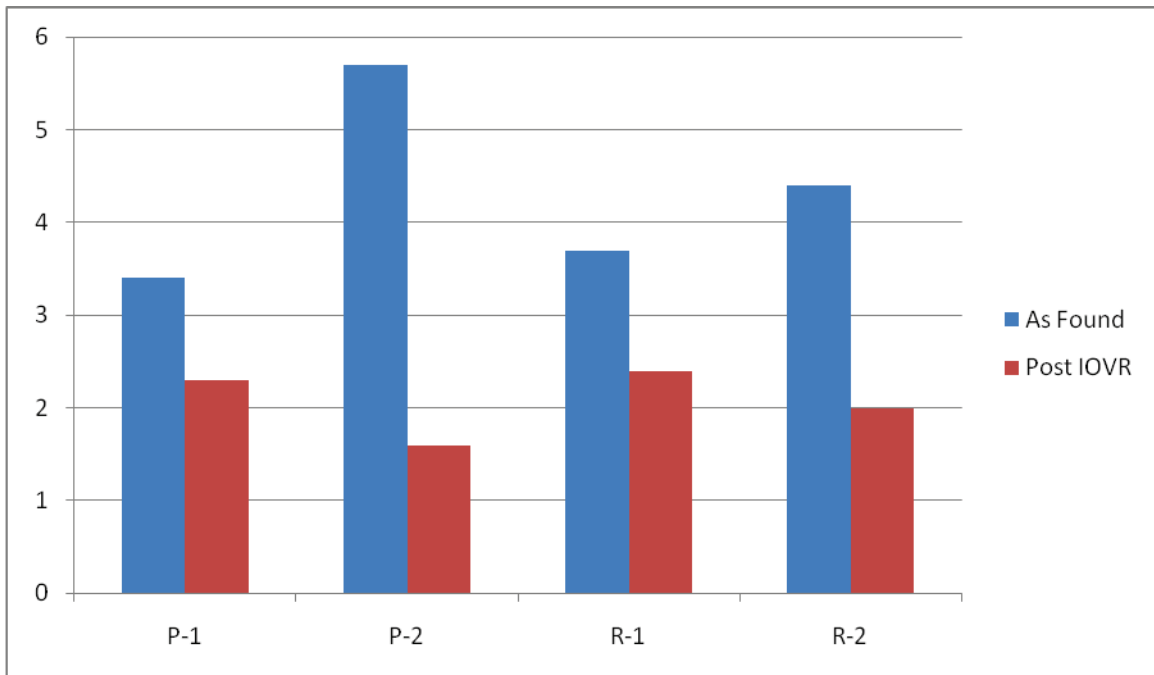
Figure 4 – String float currents before and after the IOVR+™ process.

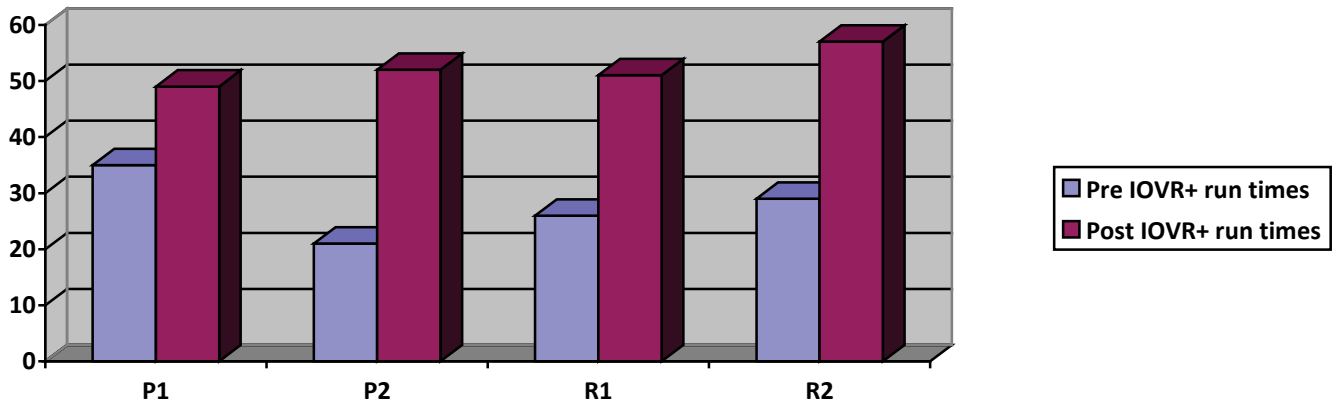
The chart below shows the (Pre IOVR+™) and post IOVR+™ process run time results. The discharge rates are identical in both the before and the after tests. The discharge load that was applied duplicated the loads that the site will actually see if off site power is lost. As explained previously the load tests that were run prior to the recovery process were all run on June 20, 2009. The follow up load tests on P-1, P-2, and R-2 were run on October 9, 2009 (Figure 5). R-1 was not tested at this time due to a system issue. We did however run a follow up load test on R-1 on January 22, 2010 (Figure 5). As can be seen in the following graph, all systems benefitted from the process with extended run times.

Figure 5 – difference in run times before and after the IOVR+™ process.
