What would you do if you found pallets of VRLA batteries in your warehouse that had manufacturing dates of 3.5 years ago, and never been charged?

**Peter DeMar
Senior Technical Adviser
Battery Research Inc.
Oswego, NY 13126**

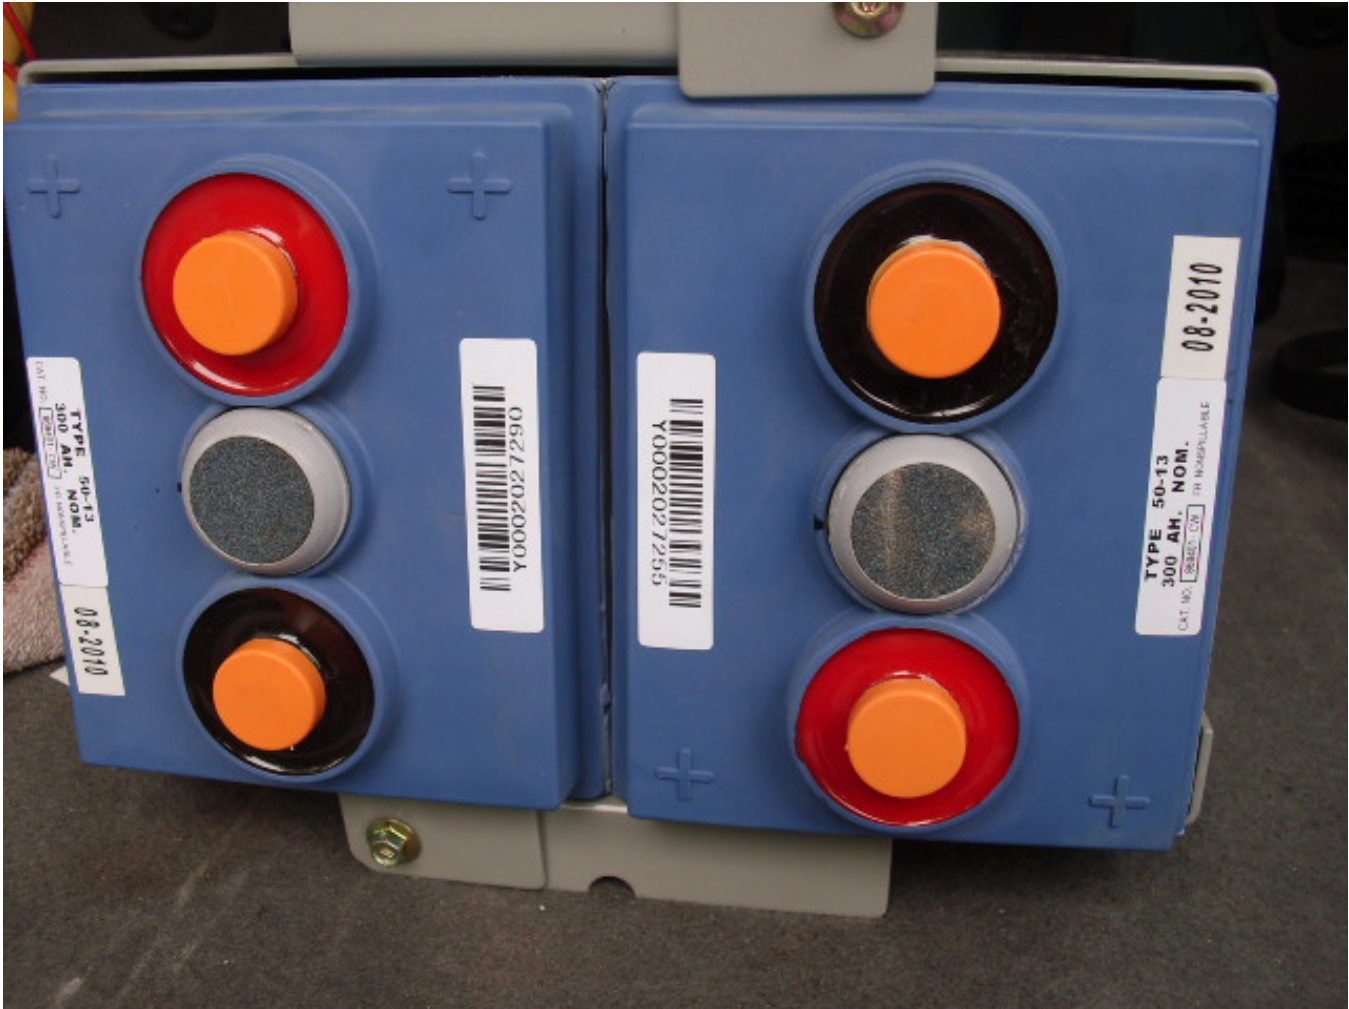
The following picture shows the two cell can that we performed the recovery process on. As can be observed, they look just like any newly manufactured cells, with the only difference being the date codes. This recovery occurred in February 2014 and the cells were date coded August 2010. This is 42 months for those monthly challenged. Three and a half years of setting off charge in a warehouse in Florida! This was going to be an interesting experiment with nothing to lose but a little time, and knowledge to be gained.

As can be seen, they look brand new and in no way damaged or deformed.

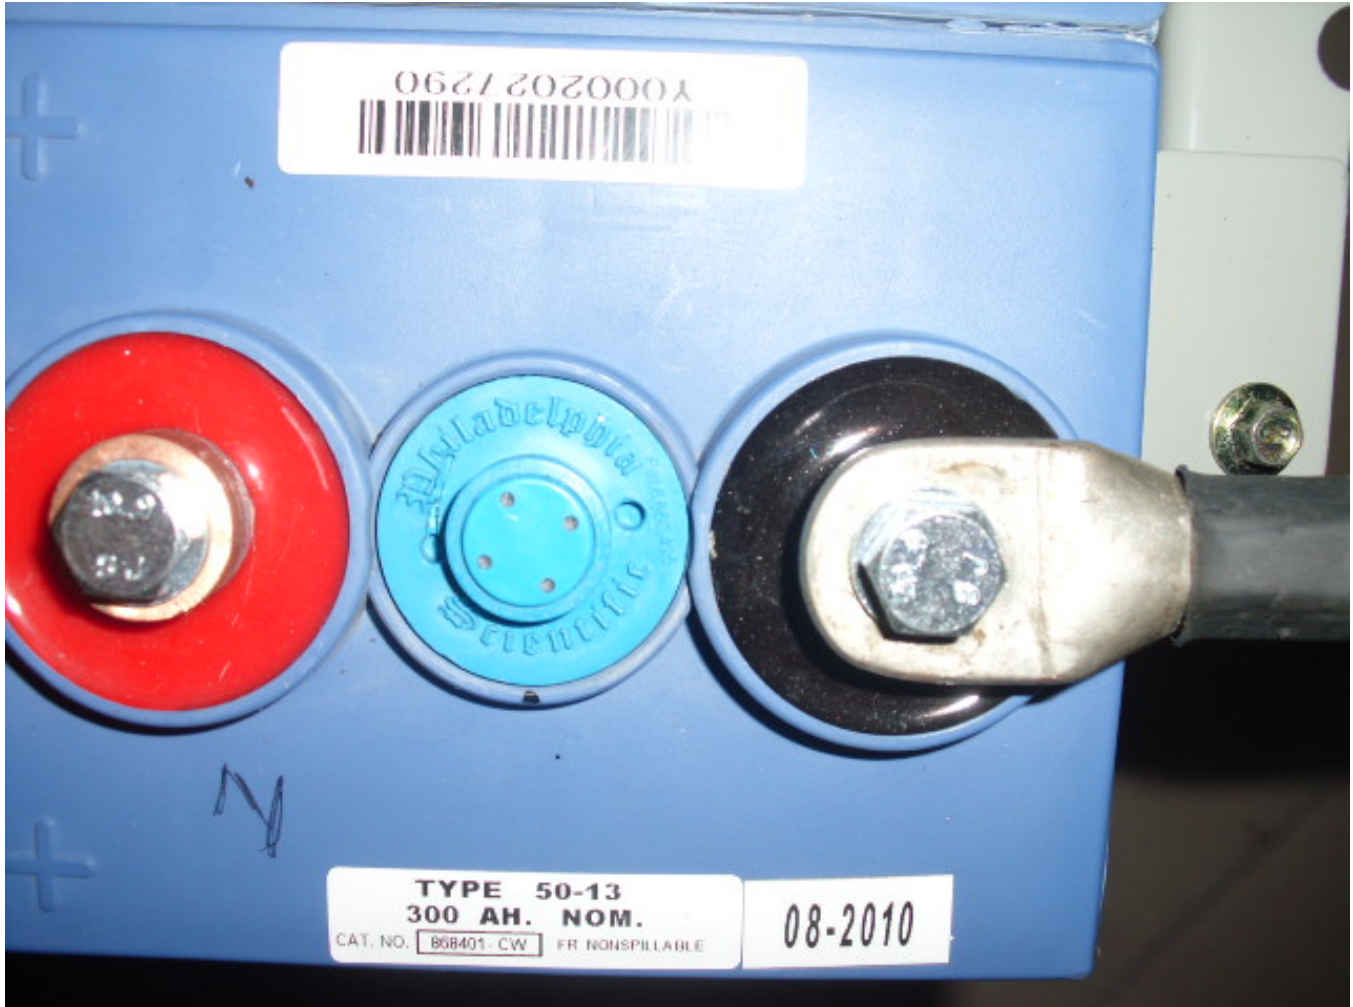
The following is a picture of cell 1 after the recovery process and with the catalyst equipped vent installed.

The following is the general procedure that anyone can follow if they attempt to do this on their own, but they might want to keep the individual cell voltage limited to 2.5 volts at standard temperature. As can be seen, it is not too complicated. With these cells, there was no need for any rehydration of any kind. We did, however, add a catalyst following the testing in order to maintain the recovered capacity.
