RESTORING CAPACITY AND EXTENDING USEFUL LIFE IN VRLA AGM BATTERIES THROUGH THE PROCESS OF REHYDRATION AND CATALYST INSTALLATION

**Peter J. DeMar
Battery Research and Testing, Inc.
Oswego, NY 13126**

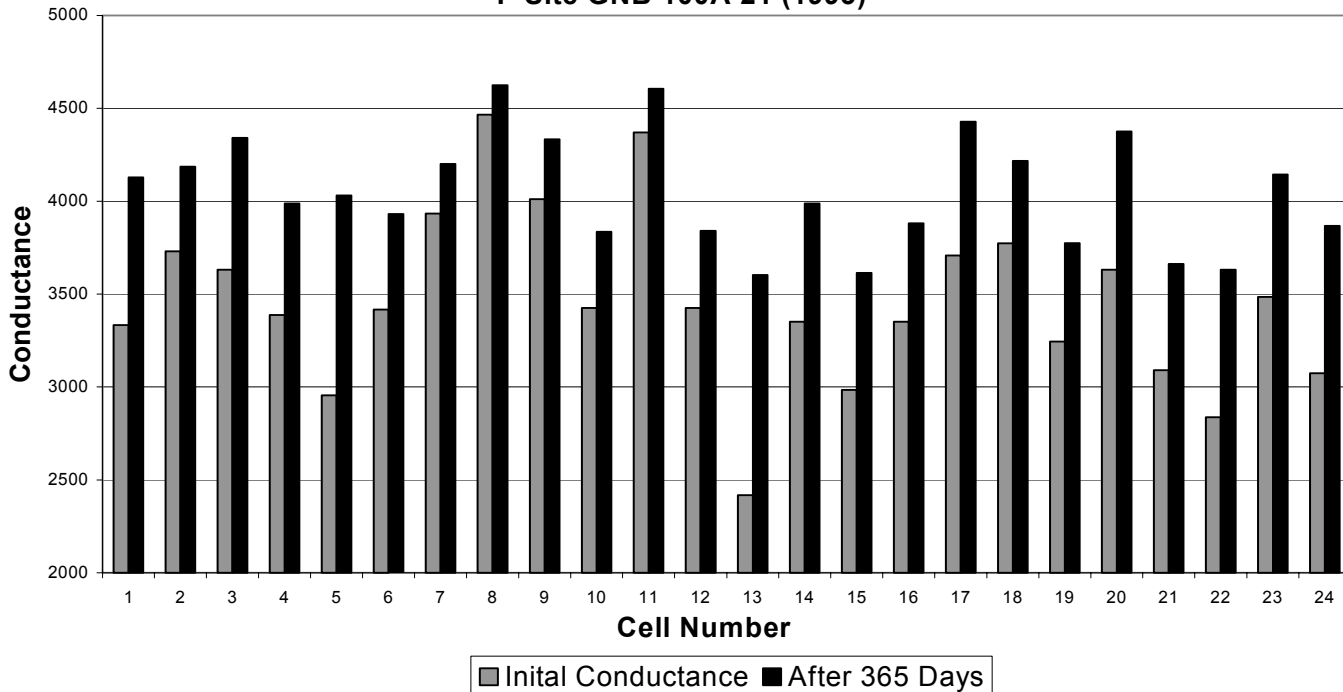
**Impact of Catalyst & Re-Hydration
P Site GNB 100A-21 (1993)**

This 24 cell 1993 GNB 100A-21 battery is rated to supply 211 amps for 180 minutes to an end voltage of 1.90 volts per cell. During the initial load test this battery supplied 211 amps for 72 minutes before reaching the 45.6 volt end voltage (40% capacity). Four days after the addition of the water and the installation of the Cat-Vent assemblies the battery supplied the 211 amps for 90 minutes (50% capacity). One year later the test was run again and the string supplied the 211 amps for 126 minutes (70% capacity). This battery obtained a 175% increase in capacity. With the actual site load which was substantially less than the rate the load test was run at, this battery could now support the site load for the amount of time required by this customer.

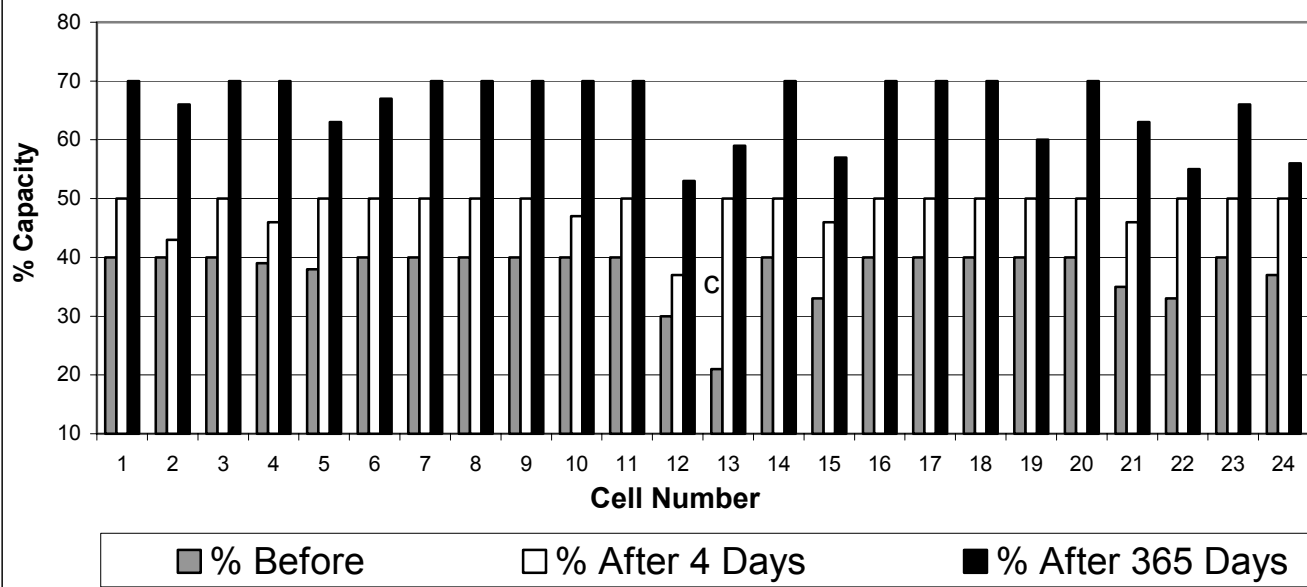
**Capacity Test Results Before & After Catalyst / Re-Hydration
P Site GNB 100A-21 (1993)**

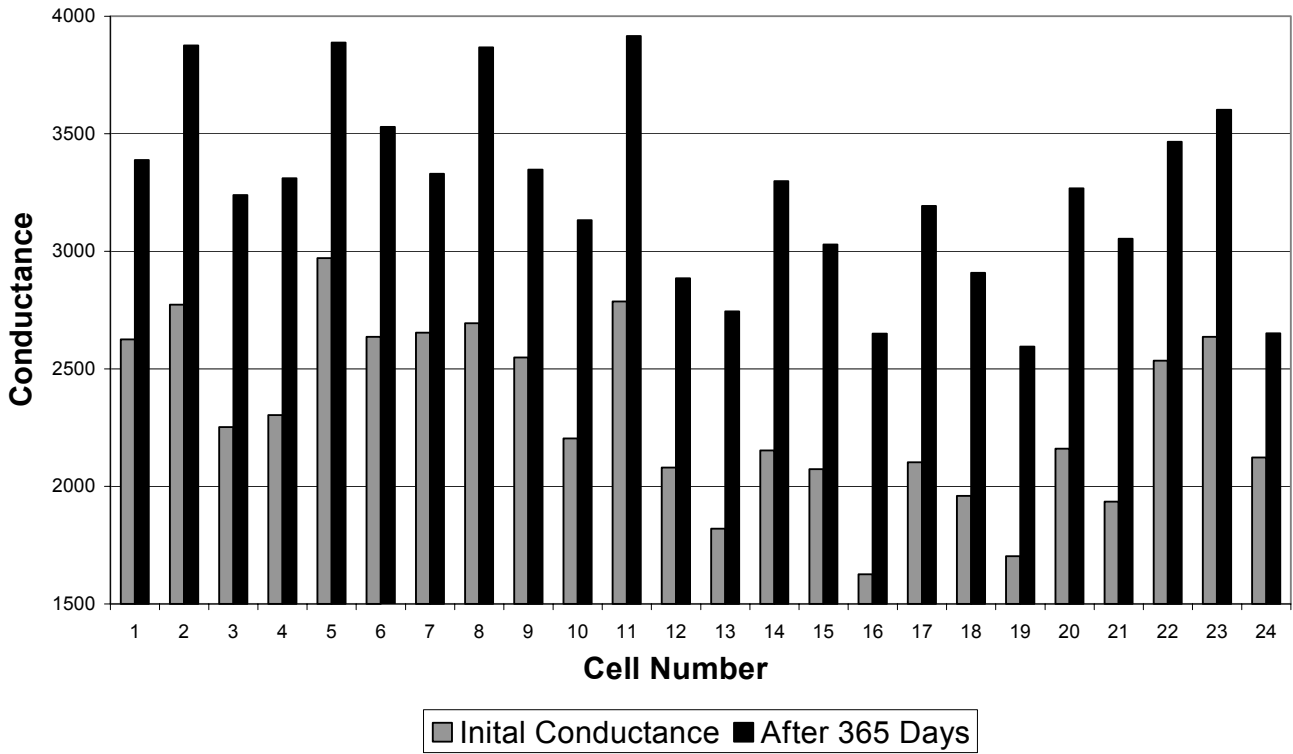
**Impact of Catalyst & Re-Hydration
W Site GNB 100A-19 (1993)**

This 24 cell 1993 GNB 100A-19 battery is rated to supply 189 amps for 180 minutes to an end voltage of 1.90 volts per cell. During the initial load test this battery supplied 189 amps for 9 minutes before reaching the 45.6 volt cut end voltage (5% capacity). Four days later following the addition of the water and Cat-Vent assemblies it supplied the 189 amps for 67 minutes (37%). One year later the test was run again and the string supplied the 189 amps for 108 minutes (60% capacity). This battery obtained a 1200% increase in capacity. This battery also had a site load that was much lower than the load test rate, and this battery also now could support the site for an adequate amount of time for this customer.

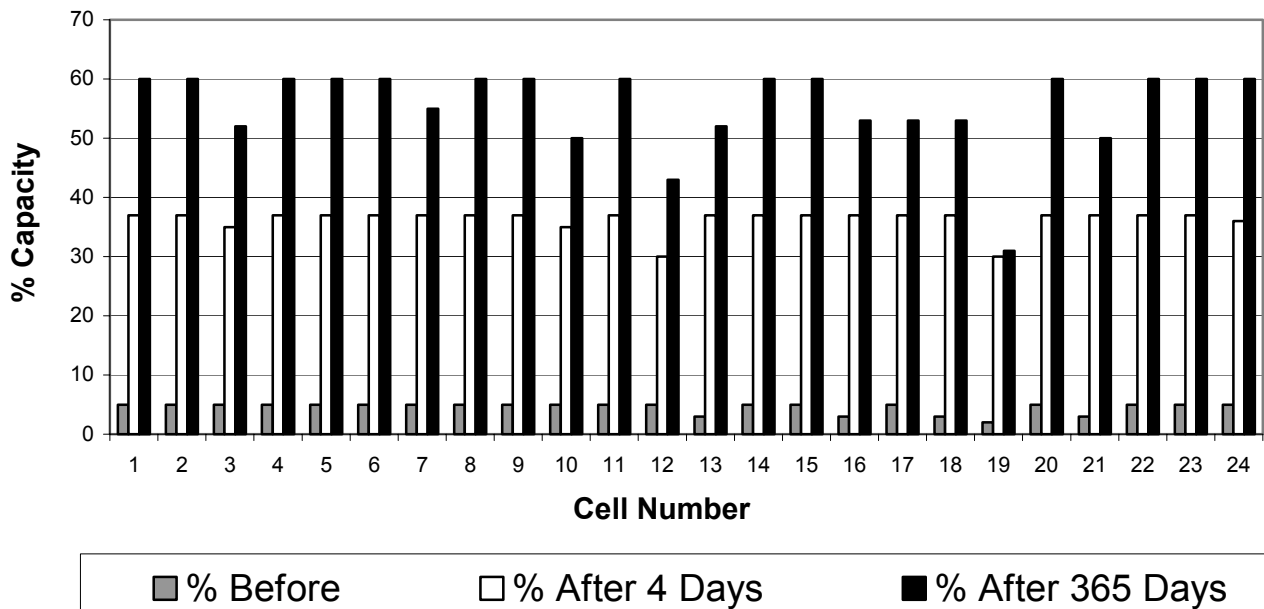
**Capacity Test Results Before & After Catalyst / Re-Hydration
W Site GNB 100A-19 (1993)**

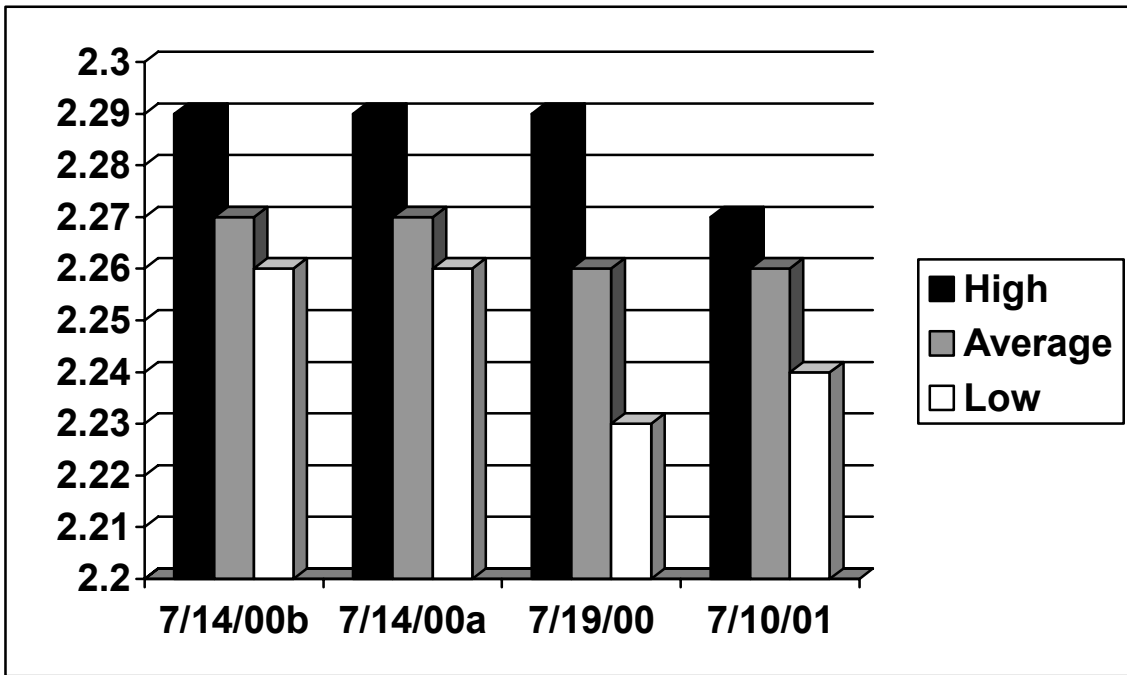
Float Voltages 75A-23

This 12 cell 1992 GNB 75A-23 battery string is rated to deliver 222 amps for 180 minutes to 1.75 volts per cell. During its initial load test it lasted 57 minutes before it reached 21 volts (32%). One week following the addition of water and Cat-Vent assemblies the battery lasted 119 minutes (66%). Following this second load test we added an additional amount of water to the two weakest cells. One year later we again load tested this battery and it supplied the 222 amp load for 166 minutes (92%). With this site we also measured the plate potentials upon the initial visit and discovered that negative plates were under polarized and that the positives were over polarized. Eighteen months later we again measured the plate potentials to see if they was an improvement, and discovered that the negatives and positives were properly polarized. The negatives had come up to where they should be and the positives had come down to where they should be. This process eliminated the overcharging of the positive plates.

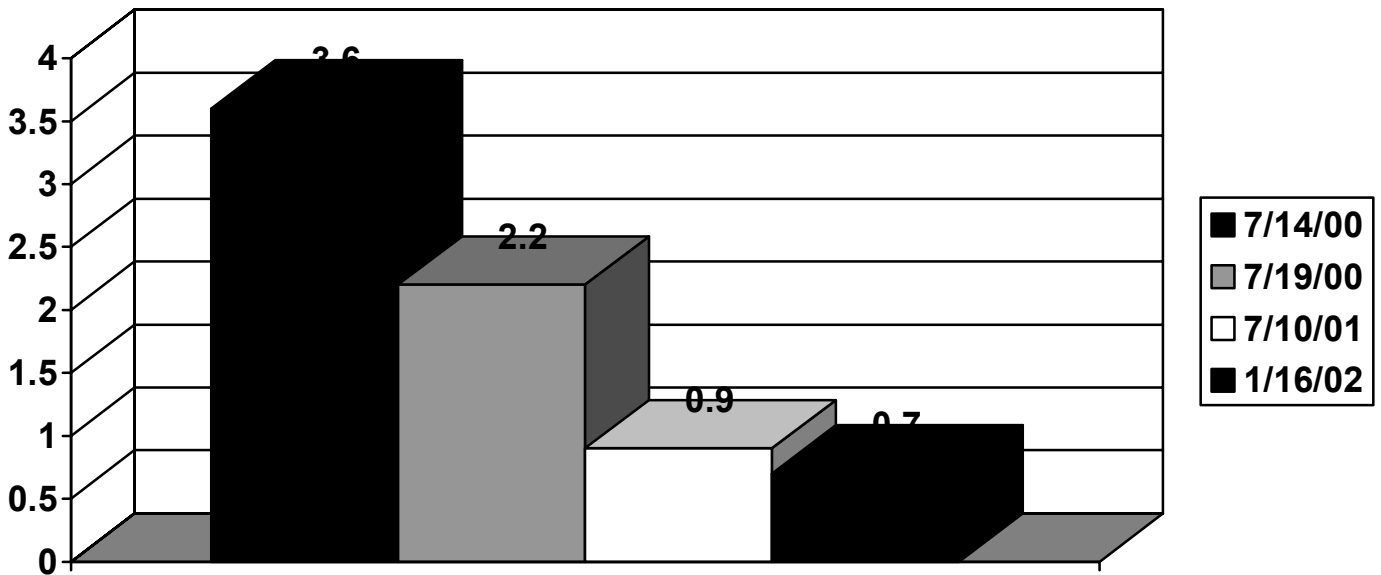
Float Charge Current 75A-23

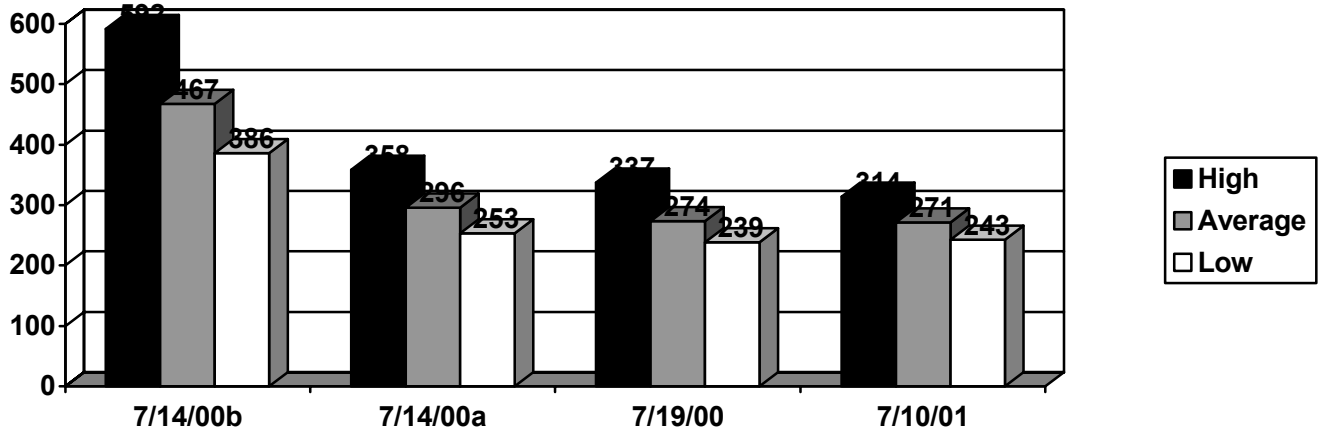
Cell Impedance 75A-23

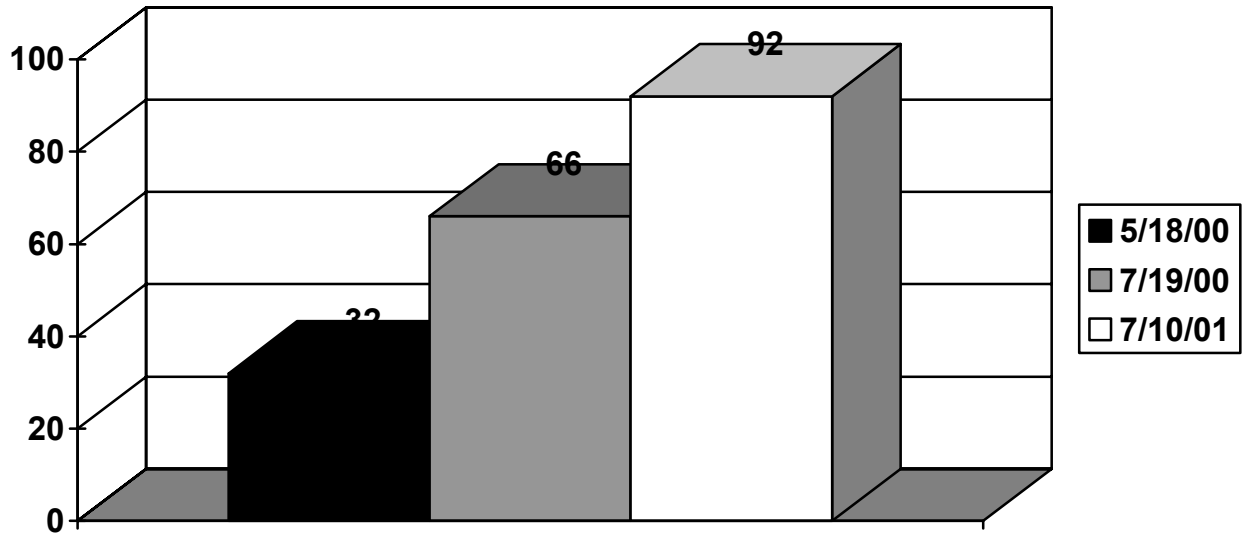
String Capacity 75A-23

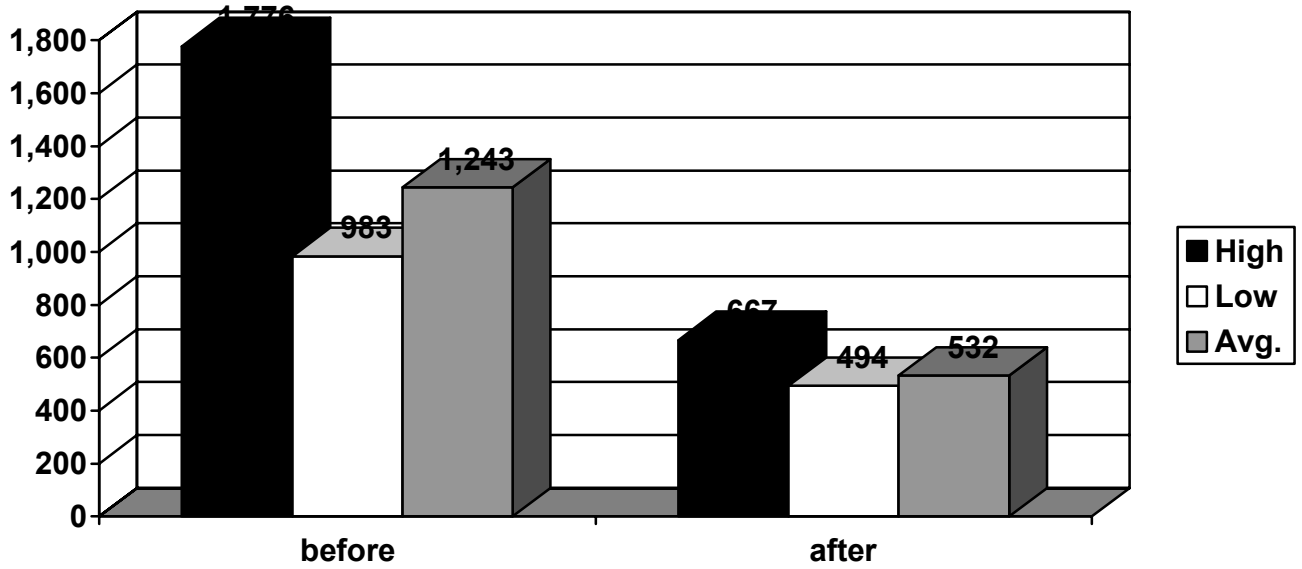
HD-300 Impedance values, before and after Rehydrating and Maximizer installation.

This 1993 C&D HD-300 battery string is rated to deliver 639 watts per cell for 15 minutes to an end voltage of 1.67 volts per cell. In other words this battery is rated to supply 116,298 watts (116KW) for 15 minutes to an end string voltage of 303 volts. During their first unanticipated "discharge test" which was when they had a loss of off site power and their battery system was supposed to carry the site through until their emergency generator started and assumed the load, the battery failed to perform. Through analysis of the site monitoring equipment it was determined that the site load was 87KW at the time of the event, and that within 45 seconds the battery voltage dropped below the 304 volts that the UPS had set as a low voltage drop out. Following the addition of water and Maximizers, and a wait of five days during which the battery was equalize charged at 427 volts for 24 hours, a controlled load test was run with an artificial load of 110 KW. The discharge test was terminated at 7 minutes and 35 seconds when the string voltage was at 318 volts. This battery improved from unable to supply the site load of 87KW for even one minute to being able to support a load of 110KW for almost eight minutes.

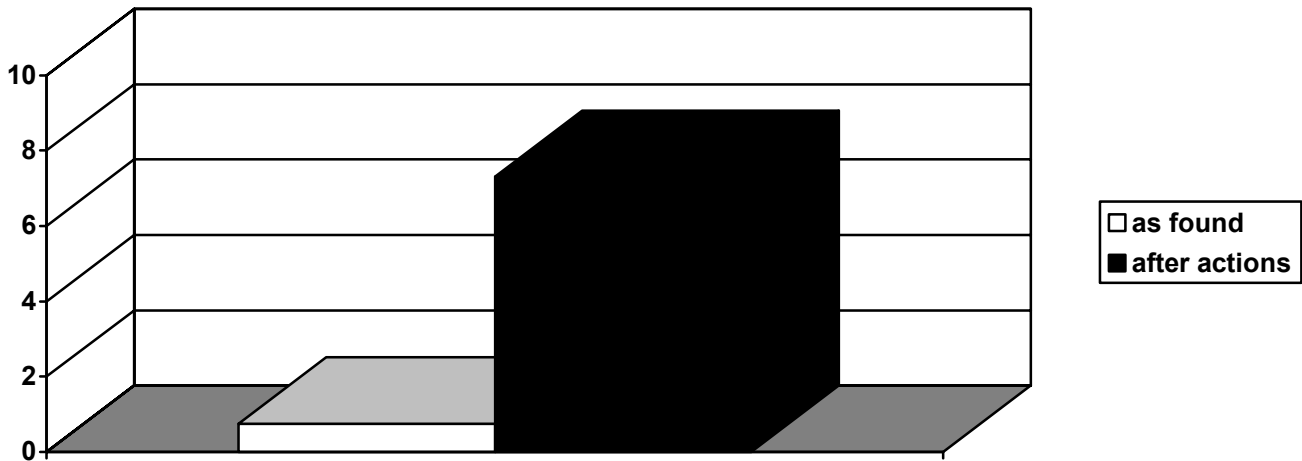
HD-300 Run time before and after Rehydrating and Maximizer installation.
