MITIGATING CONSTRUCTION AND DEMOLITION VIBRATION DAMAGE ON STATIONARY BATTERIES AND ELECTRONIC SYSTEMS: WHAT TO DO WHEN SOMEONE ROCKS YOUR WORLD

Dan McMenamin
President
Dan McMenamin and Associates, Inc.

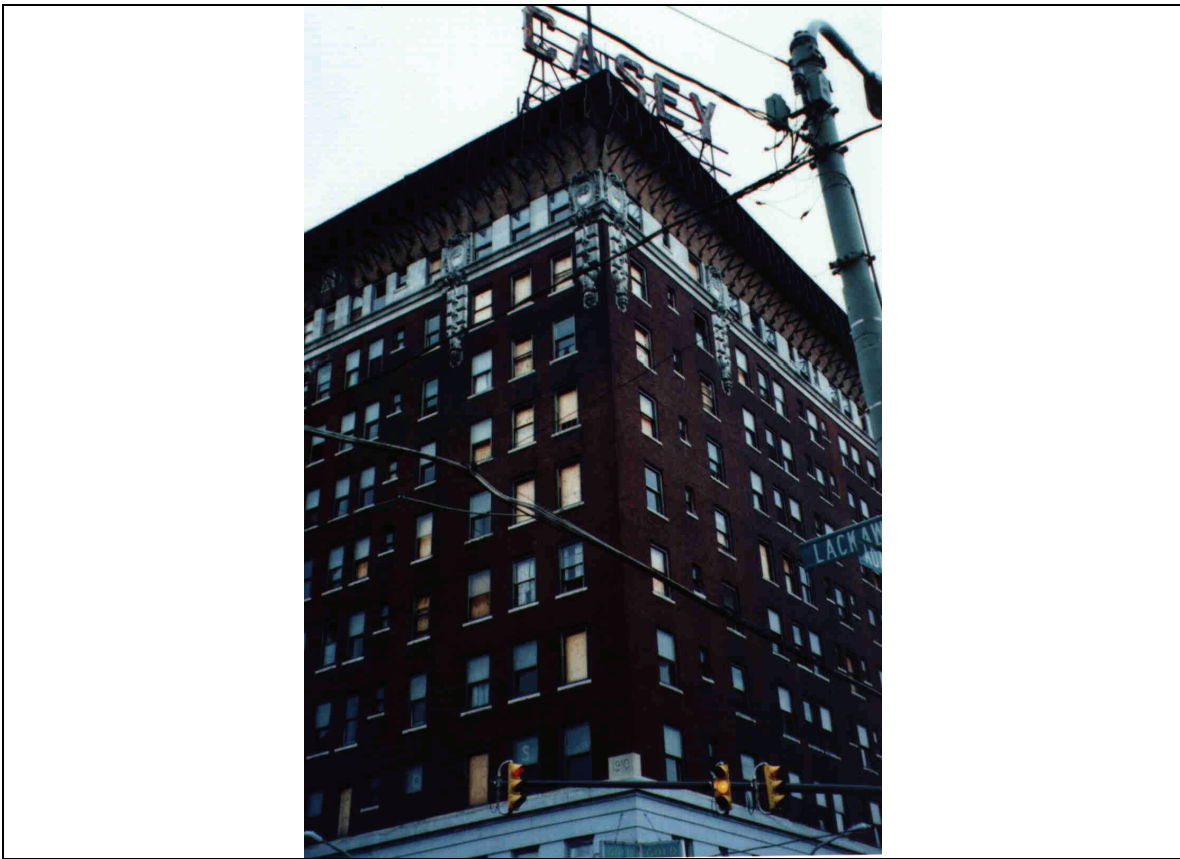
Figure 3. The Casey Hotel before demolition.

A 5-story central office building in Scranton Pennsylvania found itself in the path of redevelopment. The telephone building occupies most of a city block in Scranton, a former coal mining and railroad city about two hours north of Philadelphia. The redevelopment plan called for the demolition of The Casey, an 11-story hotel dating from approximately 1911. The central office is built only 14-1/2 feet across a narrow alley from the doomed hotel. A number of one and two story buildings across the street from both the central office and the hotel were to be razed to provide parking for a new convention hotel to be built on the site of the original Casey Hotel, as was another building behind the central office.

The soil below both the Casey Hotel and the central office is unstable bog soil and alluvium some thirty feet deep as was determined by core borings. Such soil transmits vibration very easily and is a little like building on a bowl of Jell-O. The developer wanted to demolish the Casey Hotel using an implosion because that means is faster than a conventional demolition using a wrecking ball etc. Both methods cost approximately the same and implosion is just a faster process. The other buildings were scheduled for conventional demolition. Given the weight of the building materials in the eleven-story Casey, an implosion would drop those materials producing a calculated 1.2 billion foot-pounds of energy! By calculation, it would take 63 feet of separation between the Casey and the central office in order to remain below the maximum tolerable vibration level of 0.5 Inches per Second of Horizontal Particle velocity and there was only 14 feet of separation.

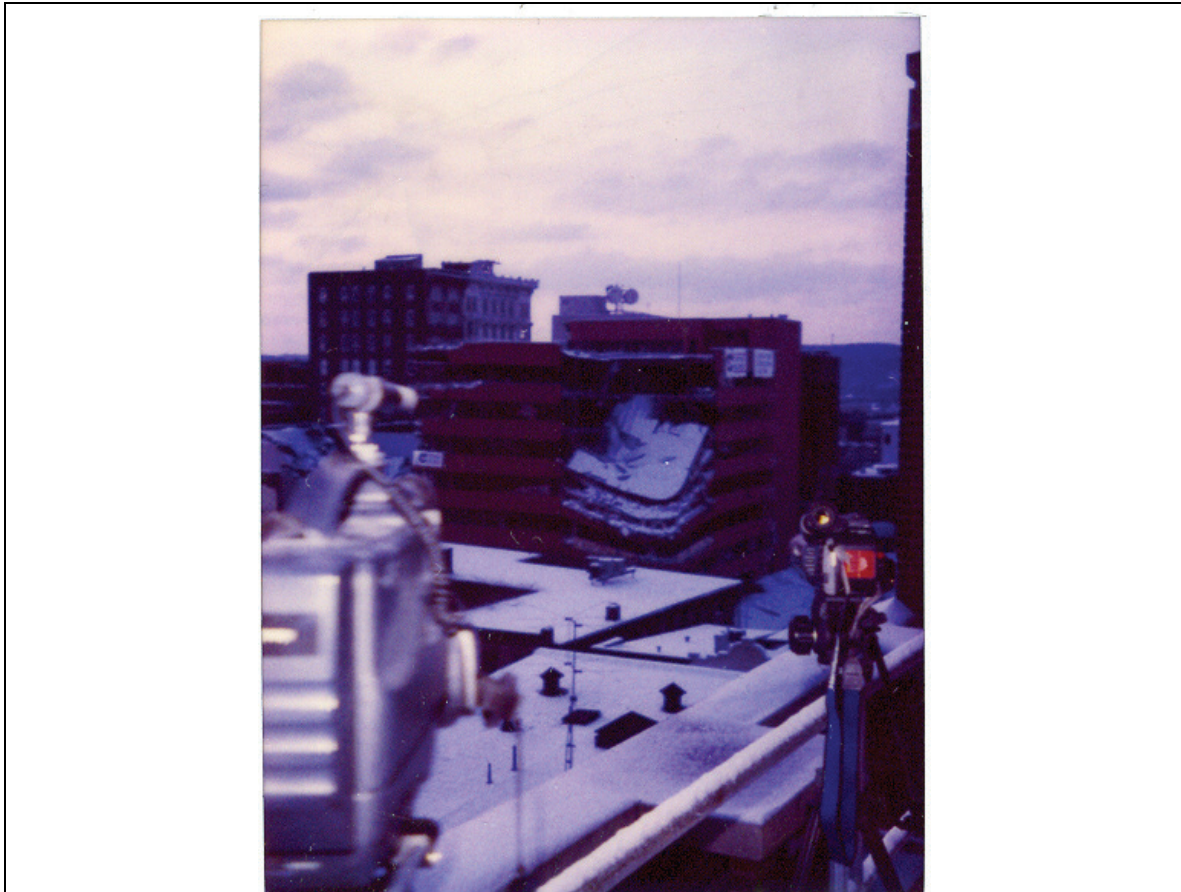
Figure 6. This photo is taken from the snow covered roof of a telephone central office in Allentown, Pennsylvania, where a pair of video cameras will record the implosion of a damaged 8 year-old office building. A sinkhole caused the structural failure of one corner of the building, as can be seen by the partial collapse.

As may be seen in Figure 6, an office building about a city block from a multistory telecommunications central office building was in need of demolition after a sinkhole caused the structural failure of one corner of the building. Due to the proximity of nearby structures the means chosen for demolition was a “pancake” type of implosion technique. Because the telephone building is 367 feet from the nearest edge implosion site there was no sufficient risk of vibration damage from the explosive blast or the impact of the building remains pummeling the ground.
