How to Avoid a Starring Role in a Really Ugly Case Study. Stupid errors easily avoided.

**Dan McMenamin
President
Dan McMenamin and Associates, Inc.
West Deptford, New Jersey**

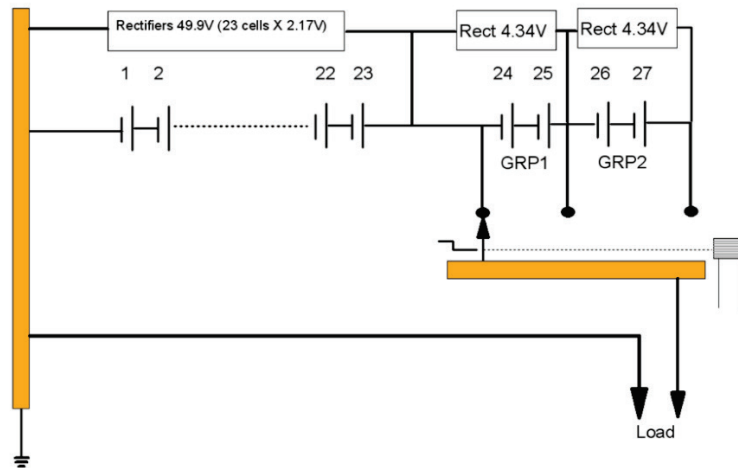
During battery discharge conditions, the motor operated switch would add two cells into series with the twenty-three cells for a time. When the bus voltage reached a low limit point, the motorized switch would add the last two cells into series and the twenty-seven cells would discharge until a return of float operation, or battery exhaust. In the event of a motor failure, the switch could be manually operated with a hand crank. Newer electronic systems that would be powered by a -48 Volt power plant were not compatible with a dc plant with cells switched in or out because of transients caused by the switch action. Accordingly, this job was undertaken to modify the plant for a twenty-four cell operation with no motor operated switch.

Figure 15 shows the normal operation of a twenty-seven cell plant. Not shown are large resistors that ensure continuity while the motor driven switch moves from one position to another.

Figure 15 Shows the normal operation of a twenty-seven cell plant.

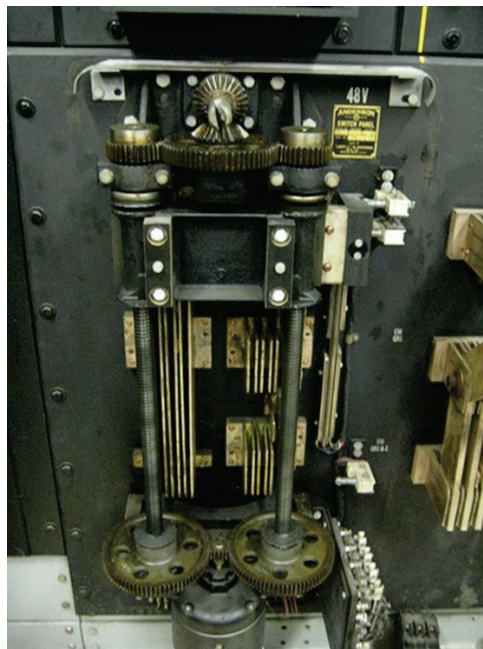
Figure 16 is of a motorized End cell switch, typical of what was in place at the job under discussion. The unit is a 3-position switch that under normal conditions is motorized or can be hand cranked if necessary.

Figure 16. An End cell switch (cover removed)

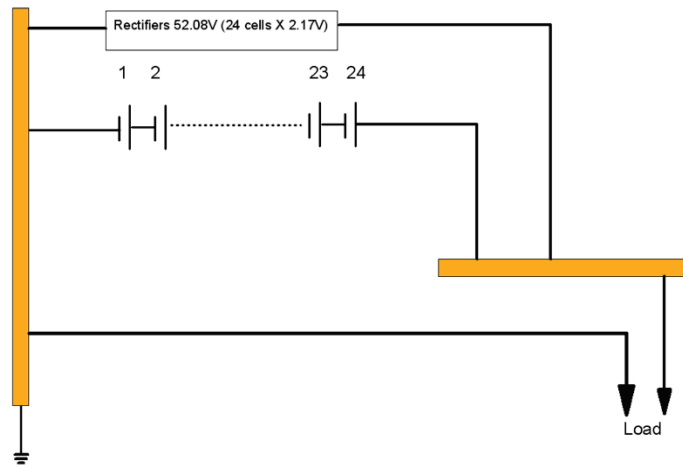
Figure 17 depicts a sketch of what was intended to be the completed job. The motor-driven switch would be removed and cells from the eight (8) parallel twenty-seven cell strings would be rearranged into nine (9) parallel 24 cell strings.

Figure 17 Sketch of what was intended to be the completed job.
