Liebert® GXT3™

Quick Start Guide – 6000VA RTL630 Models

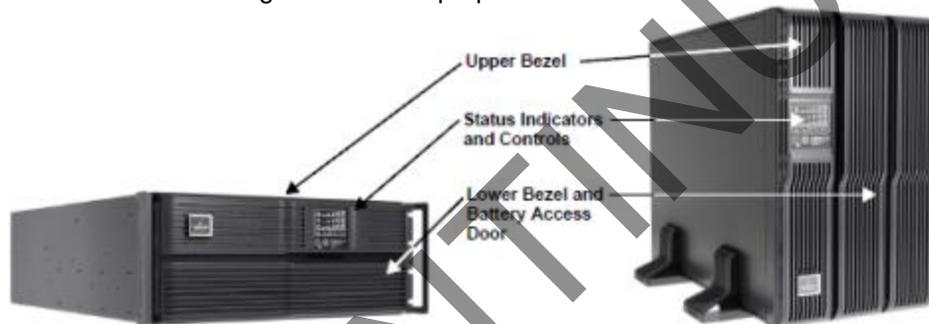
If the UPS is intended to be installed in the Tower orientation, locate the support base and spacers then assemble the two stand assemblies with an even number of spacers in each assembly. Insert the UPS between the support base assemblies with adequate space between the assemblies as shown in the picture below. *Note the display should be located on the upper half of the unit in the Tower orientation. To rotate the display with the bezels removed, depress the grooved tabs on the sides and rotate it 90 degrees clockwise.* If the USP is to be installed in a rack enclosure, follow the instructions provided with the rack mounting hardware for proper installation.

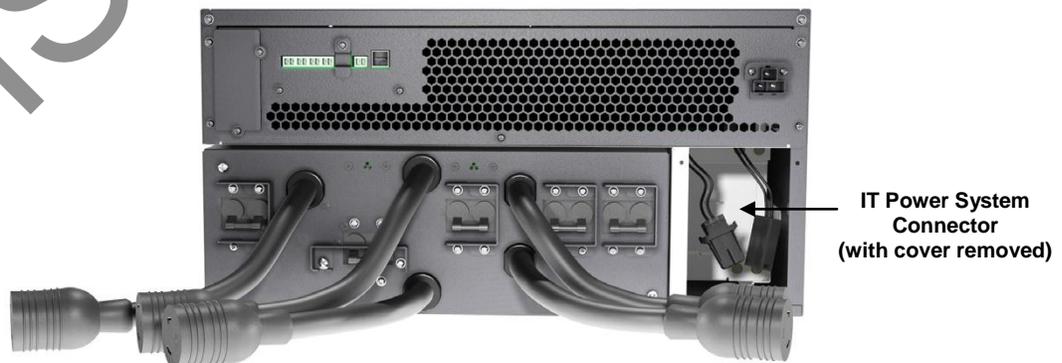
The GXT3-6000RTL630 is compatible with IT Power Systems. To configure the unit for operation on the IT Power system, remove the 2 screws securing the cover plate in the lower right hand side on the rear of the unit and disconnect the jumper, then replace the cover and secure with the screws.

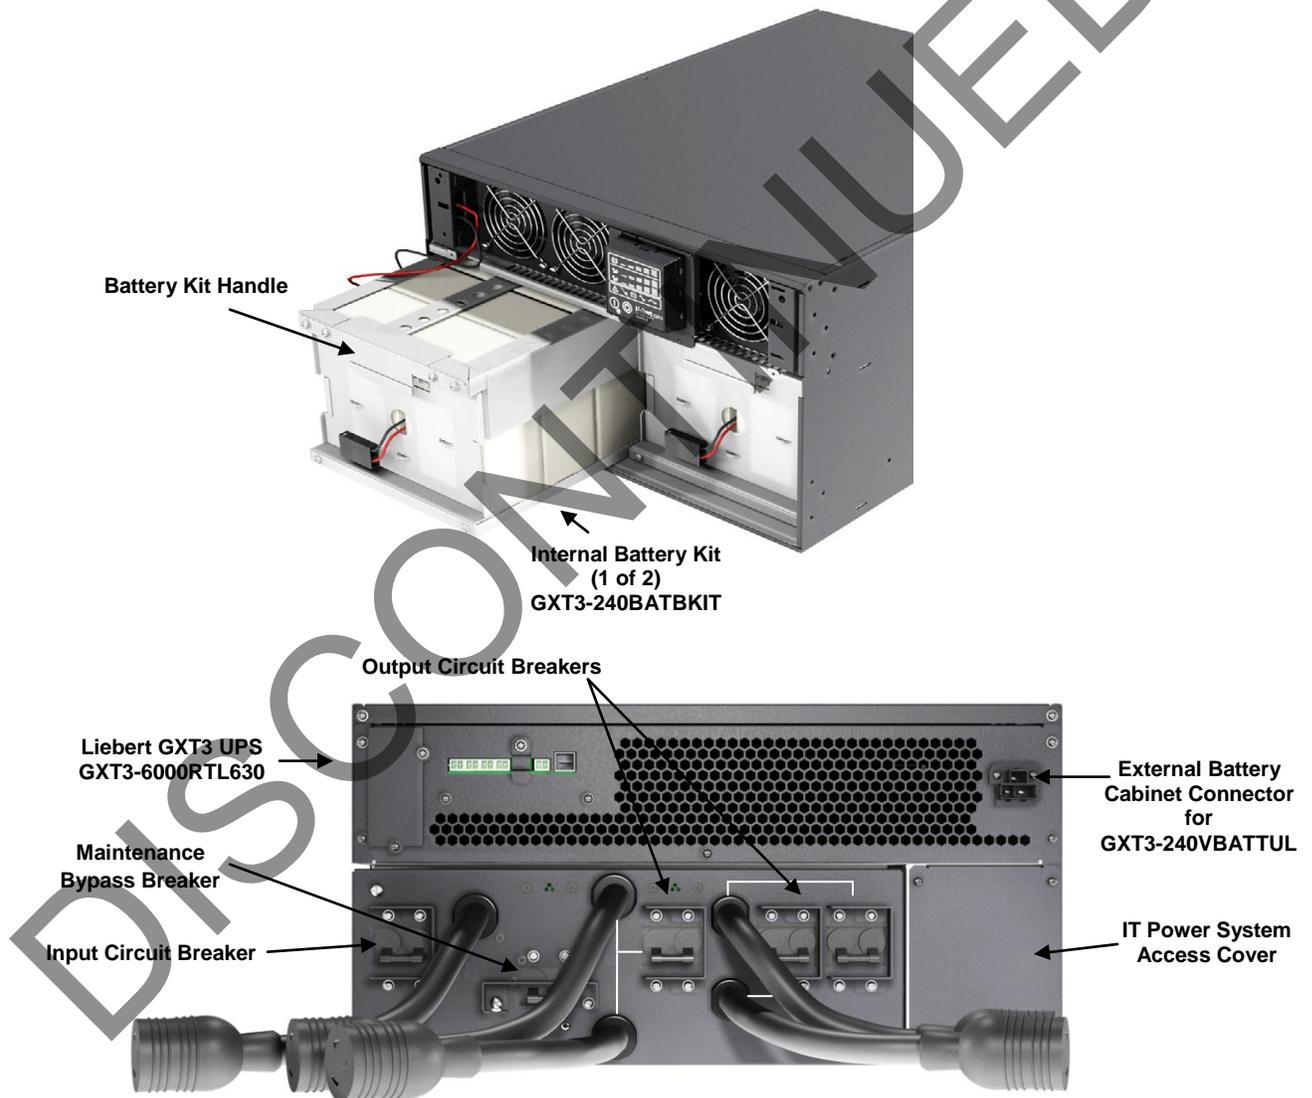
1. Loosen and remove the screws on the battery door and remove the battery door and set aside the screws and door for reassembly
2. Insert the two battery trays and connect the plugs to the mating receptacles

3. Gently push the battery wiring into the compartment making sure that the wiring will not be pinched when the battery door is reinstalled.
4. Reinstall the battery door and secure using the screws that were removed in step 1.

5. Locate the plastic bezel from the shipping box and attach the bezel to the UPS taking care to align the fastening clips on both ends before inserting them into the holes.

6. If your application requires the use of external battery cabinets for longer back up time requirements, connect the first battery cabinet to the UPS with the cable provided with the battery cabinet. *Note: it does not matter which connector is used on the battery cabinet.* If more than one battery cabinet is used the additional cabinets then connect to the adjoining battery cabinet.

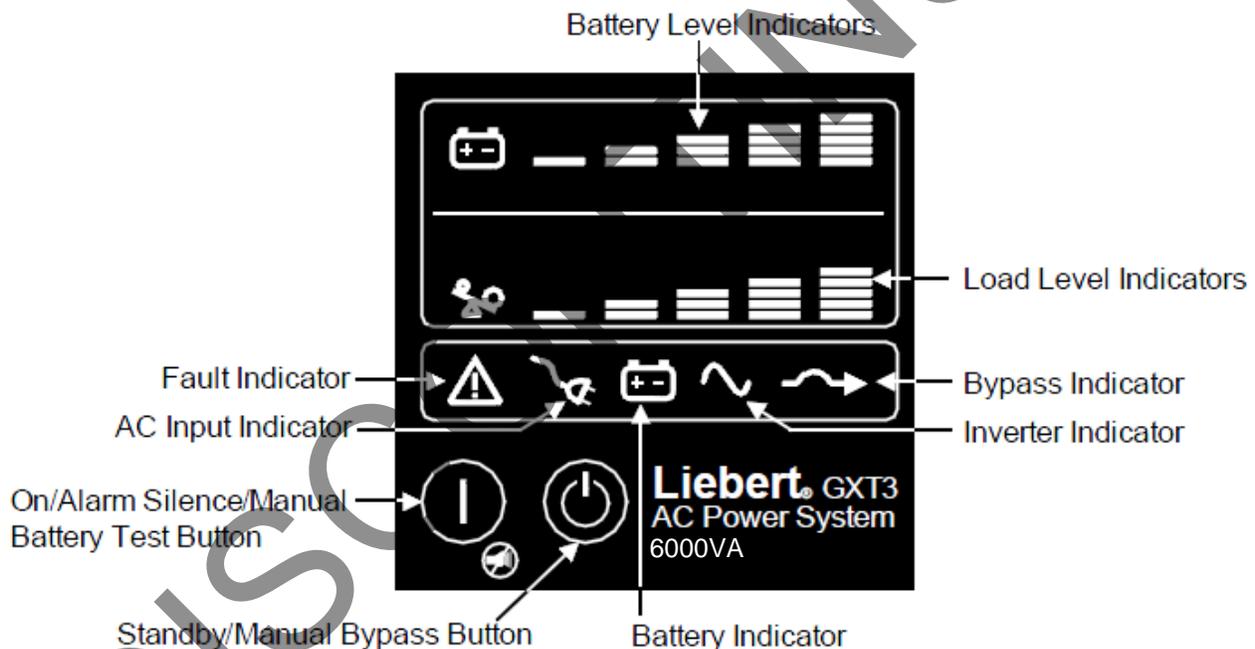
1. Ensure the maintenance bypass breaker is in the open position and that the guard is secured in place.
2. Ensure that the REPO connector on the rear of the unit has a jumper between pins 1-2 of the REPO connector or properly wired to an Emergency Power Off circuit (normally closed).

3. Install any optional Intellislot communication card into the Intellislot port on the rear of the unit.
4. Close the input breaker in the panelboard that provides input power to the UPS

5. Close the input breaker on the rear of the UPS unit. Note: the UPS will now have power and the AC Input indicator on the display should illuminate. The UPS will also begin to charge the internal batteries at this point, so there will also be battery capacity LEDs illuminated.

7. Close all output breakers on the rear of the UPS
8. If external battery cabinets are used, close all breakers on the rear of each battery cabinet
9. Press and hold for about 4 seconds, the "ON" button on the UPS display. Note: this will apply power to the output receptacles via the internal bypass and the bypass indicator will be illuminated along with an audible beep.

10. Over the next several seconds the UPS will perform the self checks and startup routine then automatically transfer the connected equipment to the inverter power. Once that is complete, the bypass indicator will turn off and the inverter indicator will illuminate.
